Cape Cod Atlas of
**Tidally Restricted
Salt Marshes**

Cape Cod, Massachusetts

Conducted & Prepared by
Cape Cod Commission
for the
Massachusetts
Wetlands Restoration Program

December, 2001

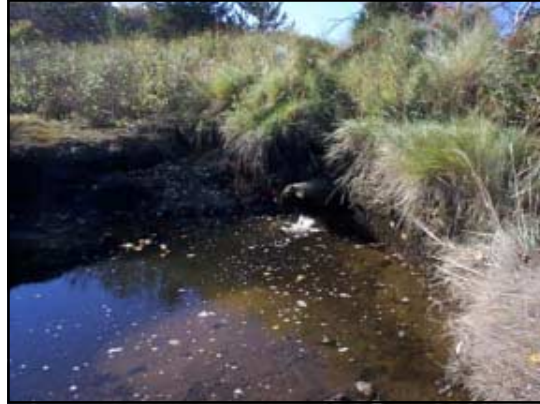
A culvert invert problem observed in Sandwich, at site SA-11 – the pipe is sited high in the bank; too high to pass the full tidal range.

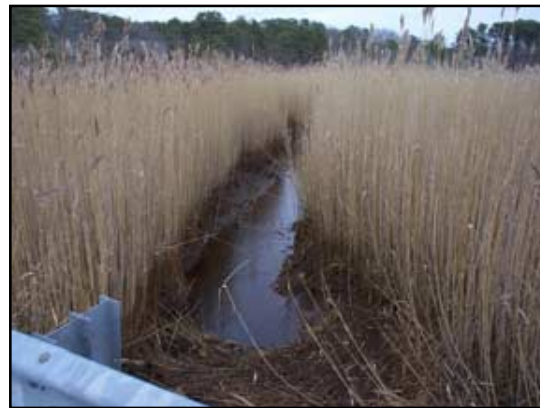
Dominant Phragmites observed growing upstream of restriction site HA-4 in Harwich.

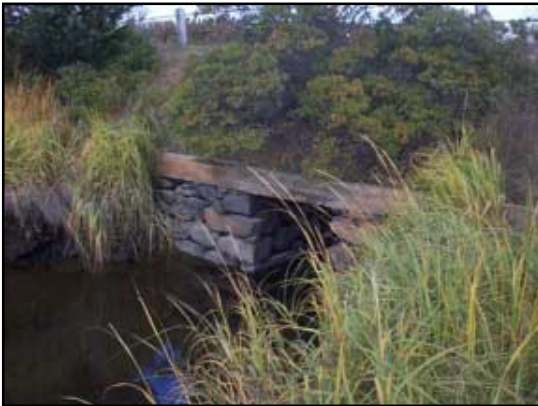
The upstream side of culvert seen here is neither broken or clogged.

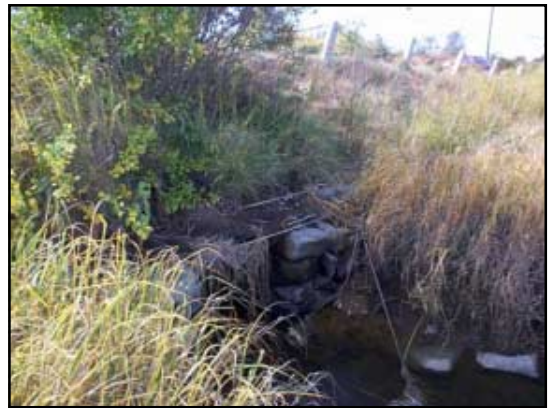
The seaward culvert opening exhibits minor decay.

Sites BA-2 and BA-3 were selected and studied by the Army Corps of Engineers (ACOE) in 1996. The study found that a 10-foot by 20-foot box culvert under both Route 6A and the railroad would provide full restoration of tidal flow. A 4 by 8-foot box culvert under site BA-2 in conjunction with the existing Route 6A culvert would provide partial restoration of tidal flow (ACOE, 1996, pp. 34-35). The Bridge Creek tidal restrictions are currently being studied by the Massachusetts Wetlands Restoration Program for potential remediation in the near future. However, to date restoration and resizing of only the seaward culvert, site BA-2, is likely.

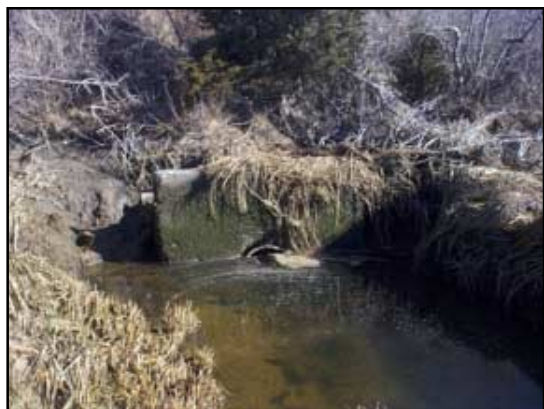
Erosion has exposed and undermined the upstream headwall; high tide lines are visible well above the opening.

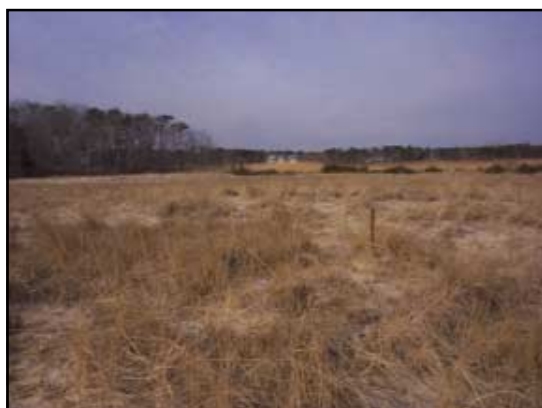
View from beach toward pond — *Phragmites* marks the pond's edge.

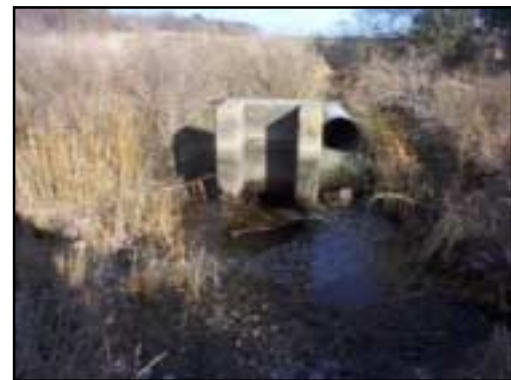
Flow is directed down through this concrete structure; broken pipe and the suspended pipe are visible in the background.

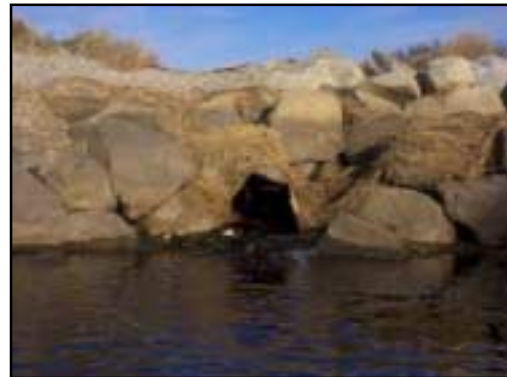
The 3-foot opening, dwarfed by the pooling water, clearly restricts natural free-flowing stream conditions.

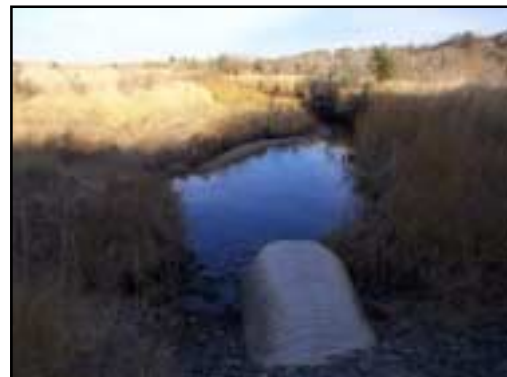
Erosion and scour are visible near the upstream opening; the channel meanders between coastal banks and salt marsh on its way to Freemans Pond.

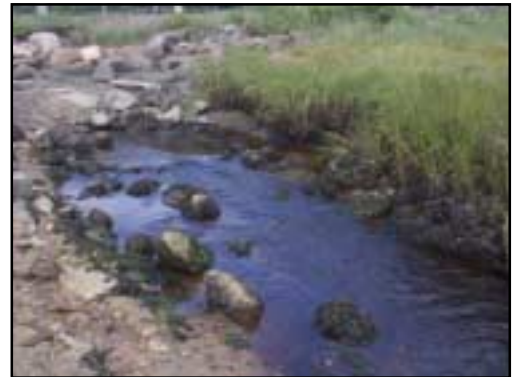
The 20-inch pipe lies partially buried under rocks at the base of the roadway berm where the channel appears to end abruptly. The pipe is broken into several segments.

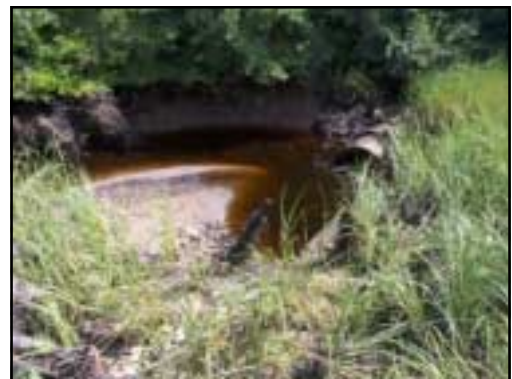
It was possible to measure the pipe on this upstream side, were it protrudes from the berm jutting into this severely scoured and eroded pool.

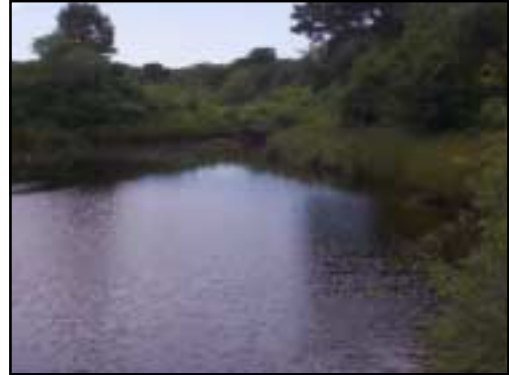
Water pools between the Route 28 berm and the upstream earthen dike – both infrastructure crossings severely restrict the flow of Frost Fish Creek.

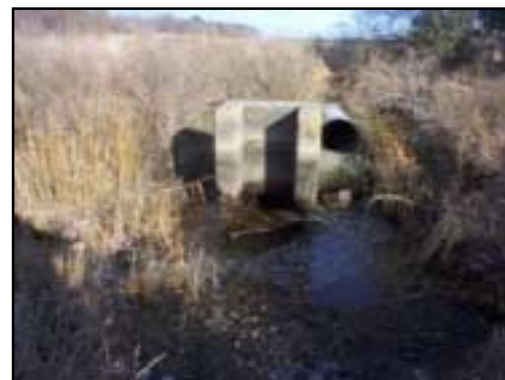
Flow is directed down through this concrete structure; broken pipe and the suspended pipe are visible in the background.

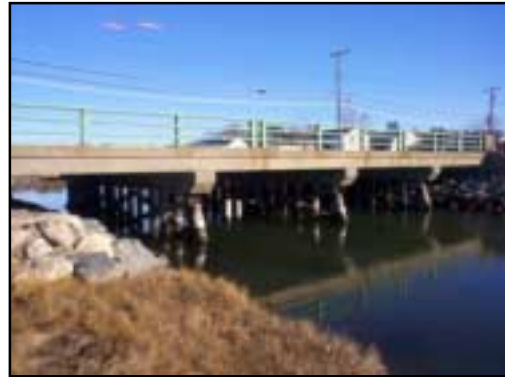
The flow of Swan Pond River passes under this 60-foot bridge span of Route 28.

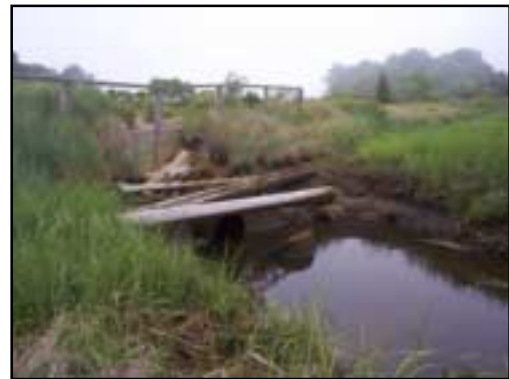
Debris marks the seaward opening of this culvert under the bike trail. Pieces of the pipe have broken off and lie in the deep scour pool in front of the opening.

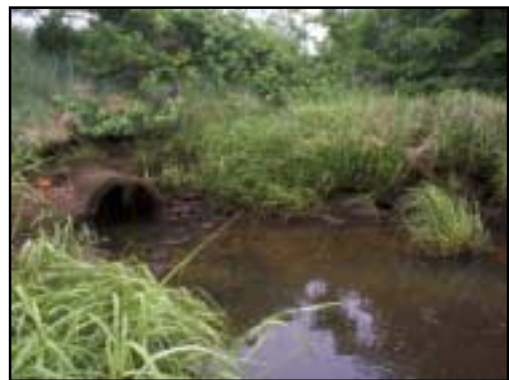
Upstream of the bike trail the bank has eroded away from this 36-inch pipe. Scour and erosion scar the area.

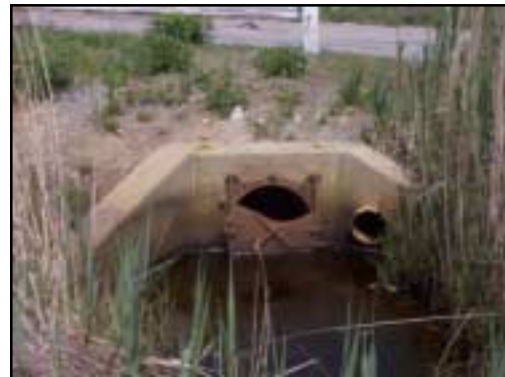
This broken clapper gate covers the 30 inch pipe and restricts the incoming tide under Governor Prence Road.

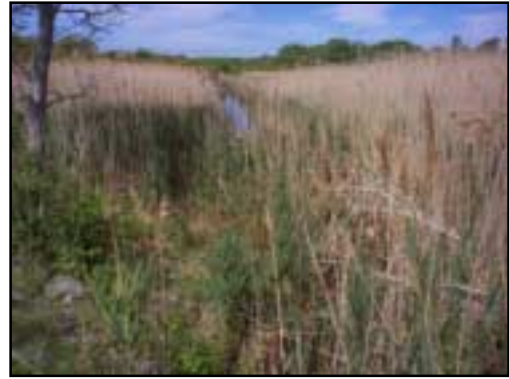
Phragmites visibly dominates the Marsh Chase Salt Marsh, an area of approximately 2.42 acres of shallow marsh between Governor Prence Road and Route 6.

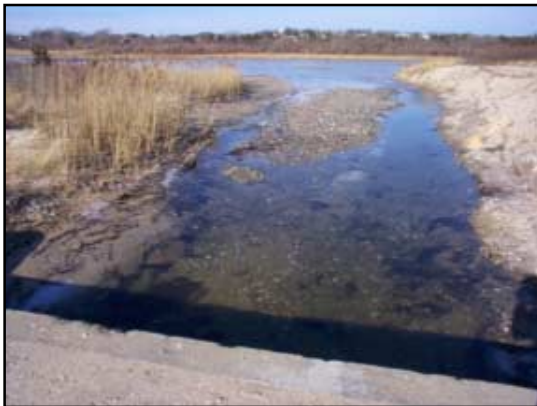
Upstream channel with fringe *Phragmites* and minor scour visible.

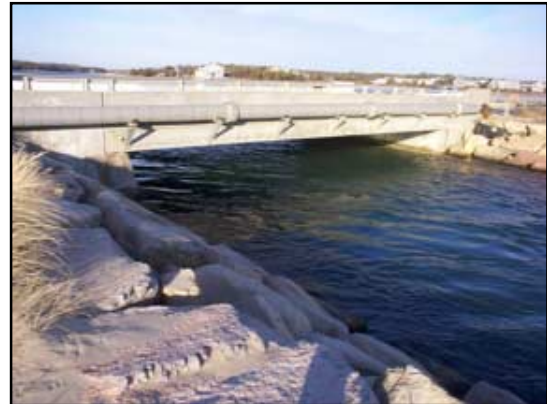
Observed during a mid/high outgoing tide, the opening on the seaward side of the bridge is nearly flowing at capacity.

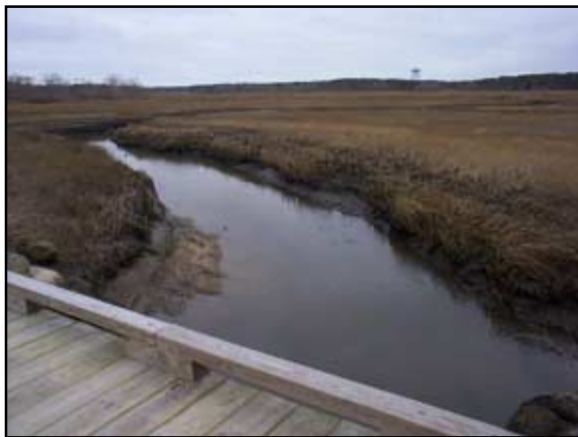
Vegetation die off is visible on the edges of this upstream channel as it flows into the extensive Herring River Marshes visible beyond.

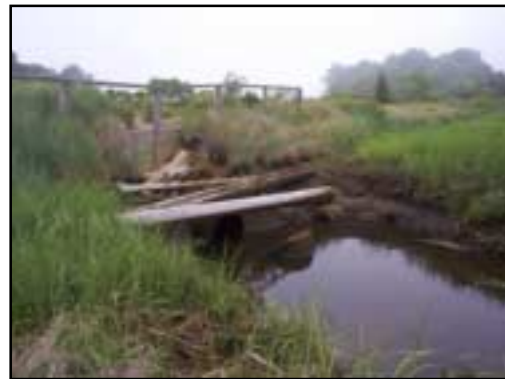
Debris marks the seaward opening of this culvert under the bike trail. Pieces of the pipe have broken off and lie in the deep scour pool in front of the opening.

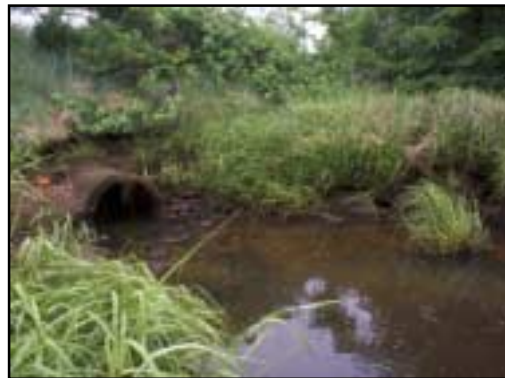
Upstream of the bike trail the bank has eroded away from this 36-inch pipe. Scour and erosion scar the area.

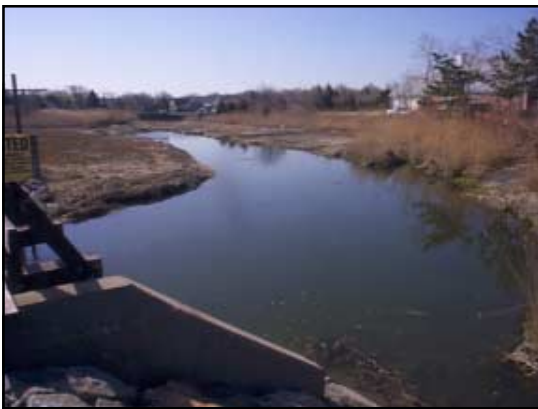
The upstream affected salt marsh, seen here at high tide, is fringed by Phragmites.

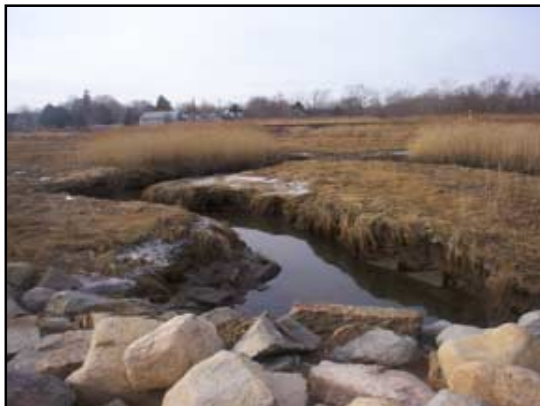
In the upstream salt marsh Phragmites fringes the marsh as well as growing in scattered patches. The railroad bed, which causes further restriction of the creek, is visible in the background.

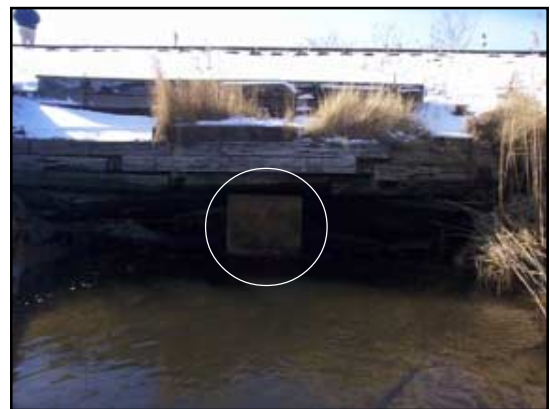
The flapper gate which covers the 3-foot pipe, is set low, below a deteriorating retaining wall.

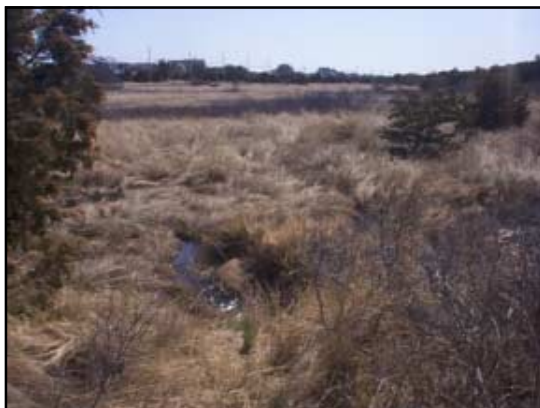
The upstream affected area is dominated by grasses and shrubs; the stream channel is barely visible in the foreground.

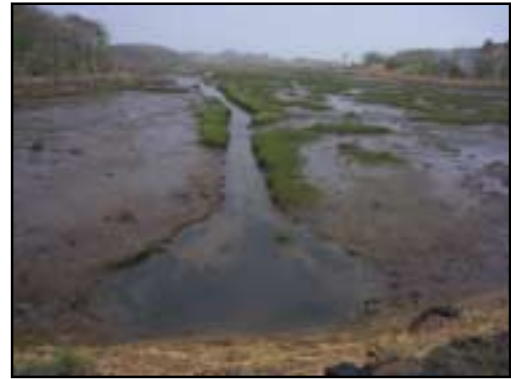
The seaward marsh area is degraded, displaying vegetation die off, ponded water, and a major scouring basin.

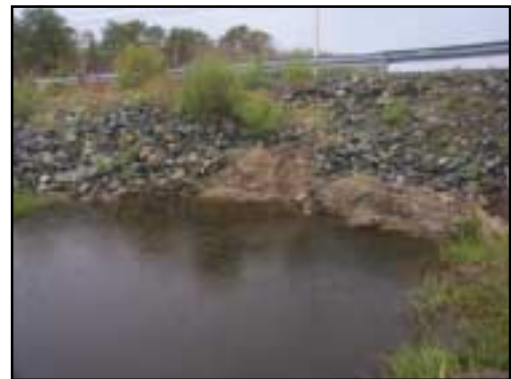
The berm of Old County Road partially dams Eagle Neck Creek. The upstream pipe is visible in this pool and is blocked by rocks – further restricting tidal flow.

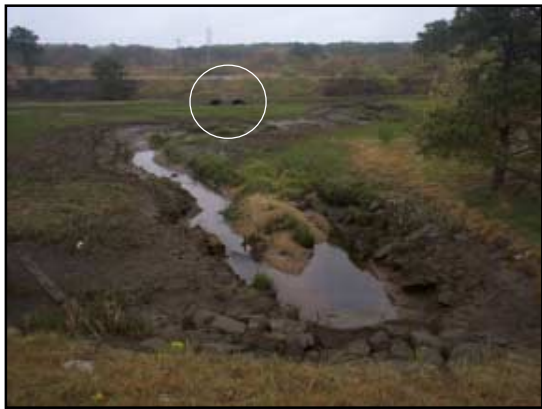
When standing on Route 6, looking into the 1.96 acres of salt marsh that lie between it and the Rail Trail, the view is dominated by these badly degraded channel banks and marsh surface. Circled in the rear of this photo are the 2 culverts (site WE-d) that pass the flow of Blackfish Creek under the trail.

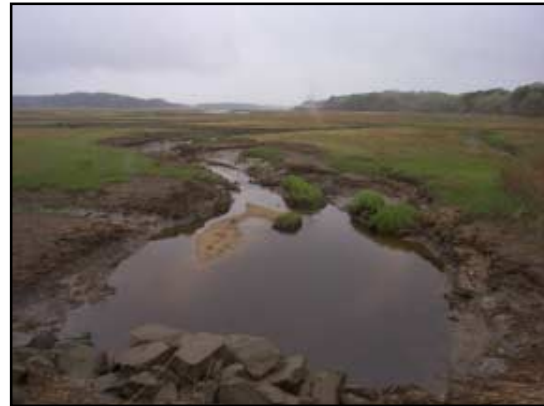
Looking from the culvert into the seaward salt marsh area several visual indicators of a restriction dominate the view, including vegetation die off, scouring, erosion, and marsh slumping.

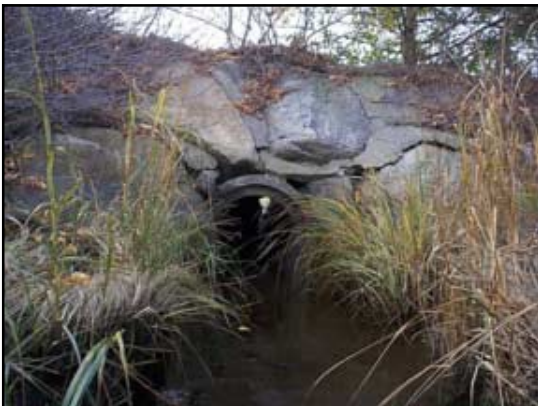
The upstream side of the Thacher Shore Road pipe is not deteriorating, likely due a low volume and velocity of tidal waters able to pass through it.

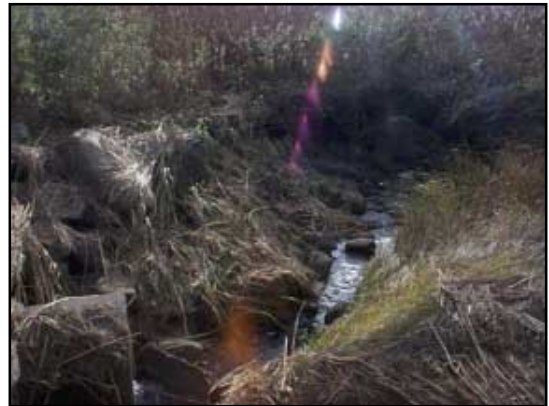
Erosion and scour are deteriorating the banks of the channel adjacent to the seaward opening of the pipe.

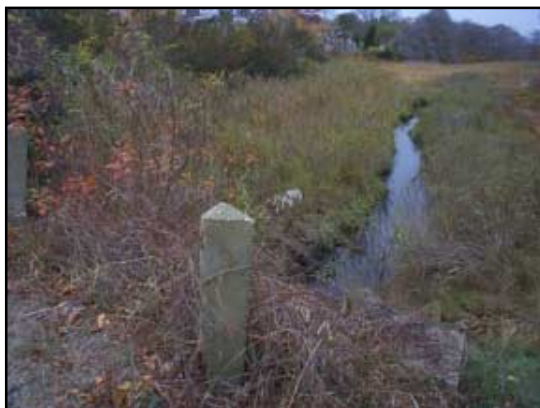
Although delineated as salt marsh, *Phragmites* has a significant presence in this upstream affected area.

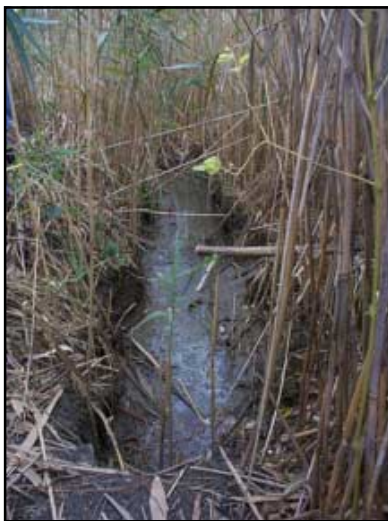
Phragmites visibly dominates the upstream affected area.
