# Ipswich Mills Dam Partial Feasibility Study

Preliminary analysis of three primary factors that may influence the cost and feasibility of the removal of the Ipswich Mills Dam, Ipswich, MA

April 23, 2014

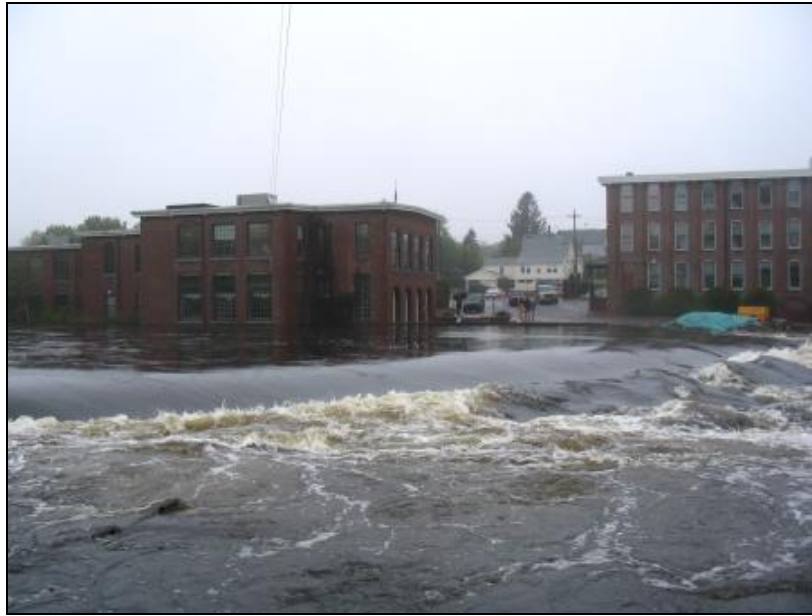
**Figure 2a. Ipswich Mills Dam on May 16, 2006, facing southwest (photo provided by IRWA)**

In addition, the USGS maintains a gage located 200 feet downstream from the Willowdale Dam, or 25,000 feet upstream of the Ipswich Mills Dam, and has continuously recorded water surface elevation and discharge data as far back as June 1930. Monthly mean flows at the Willowdale Dam between 1930 and 2009 range from 42.0 cubic feet per second in August to 446 cubic feet per second in March. Appendix A presents the monthly gage data according to the USGS analysis of data between June 1930 and 2009. The highest flow on record of 4,600 cfs occurred on May 16, 2006. Two photos of the

Ipswich Mills Dam on May 16, 2006 are provided below (Figures 2a and 2b), showing that the dam is virtually drowned out by the discharge in the river.

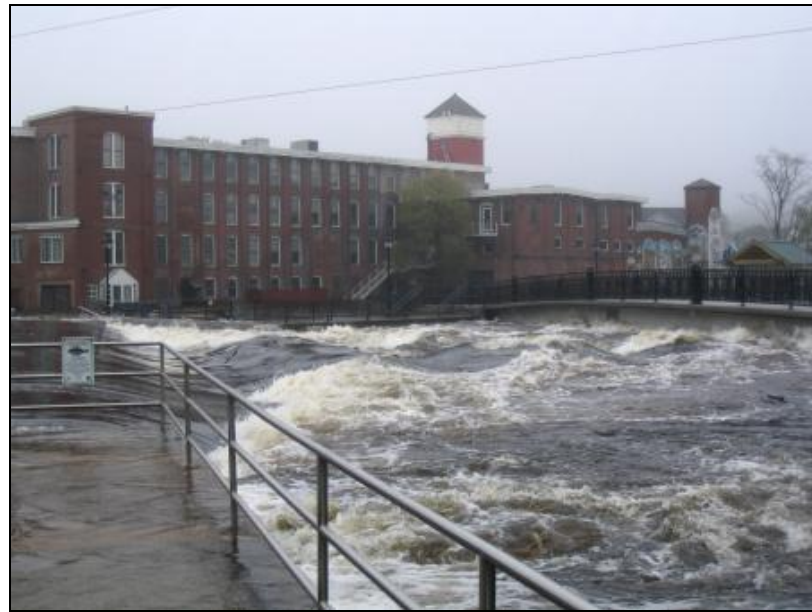
**Figure 2b. Ipswich Mills Dam on May 16, 2006, facing northwest (photo provided by IRWA)**

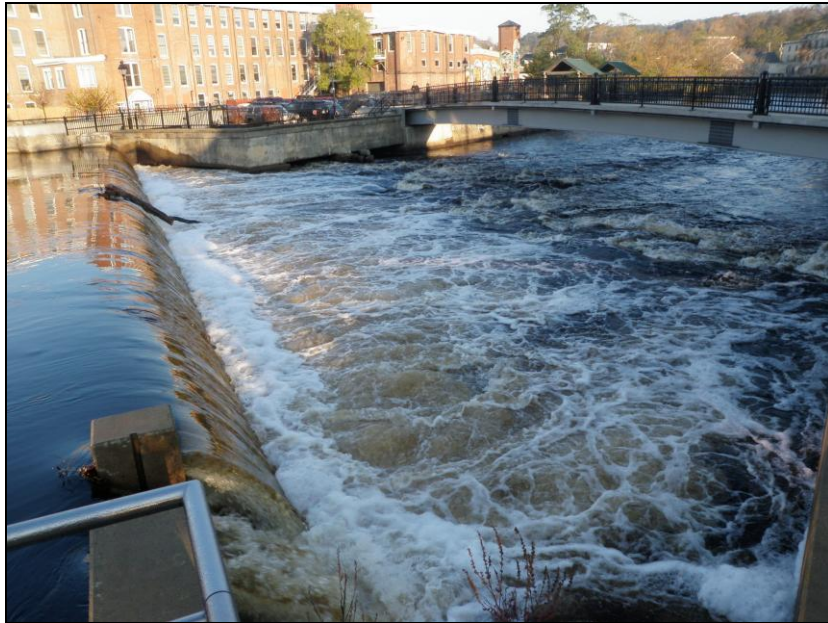
**Figure 4a. The Ipswich Mills Dam is a run-of-the-river mill dam formerly used to power the nearby mills.  
(Horsley Witten Group, November 2011)**

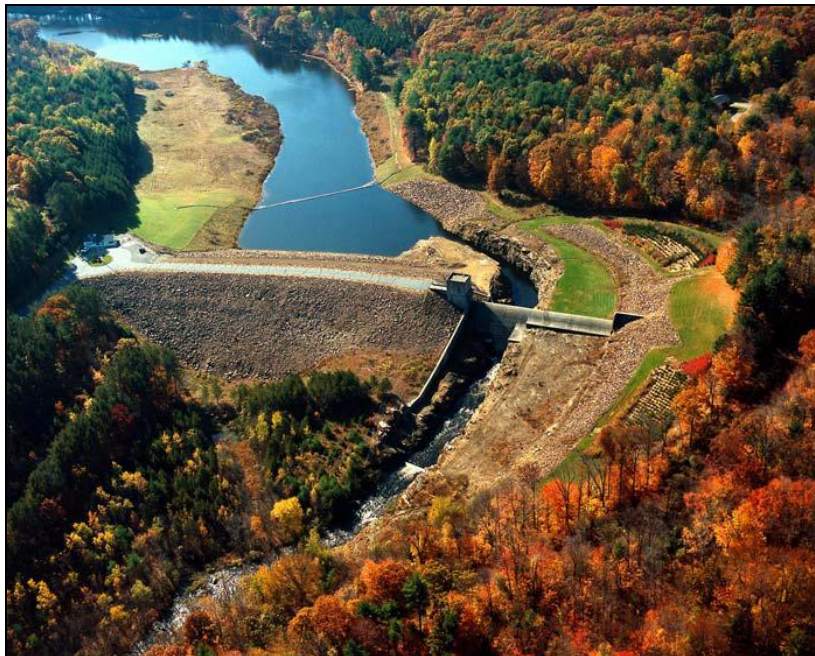
**Figure 4b. The Westville Lake Flood Control Dam on the Quinnebaug River in Southbridge, MA serves to control flooding to downstream areas. This dam serves an entirely different purpose than the Ipswich mills Dam. (US Army Corps of Engineers)**

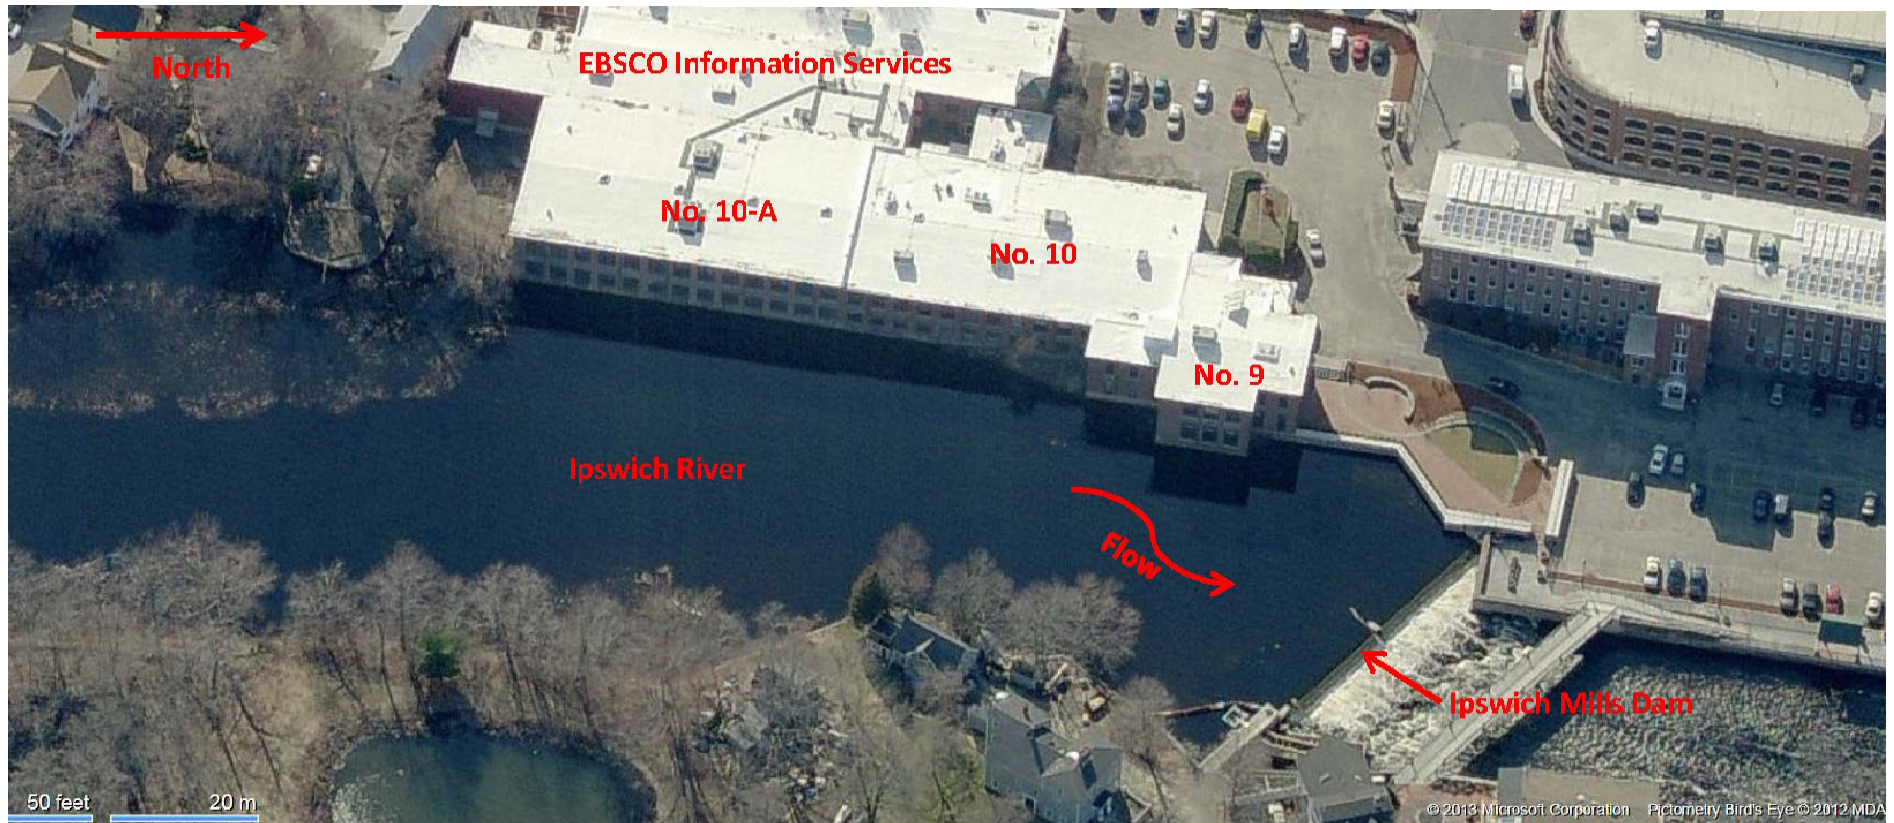
Fig. 1 - Aerial View of Project Area

The EBSCO Information Services' buildings that are the subject of this evaluation are the buildings located on the west side of the river immediately upstream of the dam as shown in Figs. 1 and 2. These buildings, which are identified as Nos. 9, 10, and 10-A in the plan in Appendix B, were constructed between approximately 1901 and 1912. Building Nos. 6, 7, 8, and a portion of No. 9 no longer exist. No other plans are reportedly available for the buildings.

As shown in the plan in Appendix B and in Figs. 1 and 2, the east side of Building Nos. 9, 10, and 10-A are located immediately on the property line and buildings directly abut the river for most of their length. As shown in Figs. 1 and 2 and based on our observations and review of historic aerial photographs, the ground surface is above the river level along a portion of the buildings.

Mr. Thomas Wheeler of EBSCO provided GEI with the logs of three soil borings that were performed in 2009 immediately south of the southeast corner of Building No. 10-A. The general location of the borings is shown in Fig. 1 and a more detailed plan showing the boring locations is provided in Appendix C. Logs of the borings are also contained in Appendix C. The two borings closest to the river (B-3 and B-4) both encountered about 16 feet of loose fill, soft to medium stiff

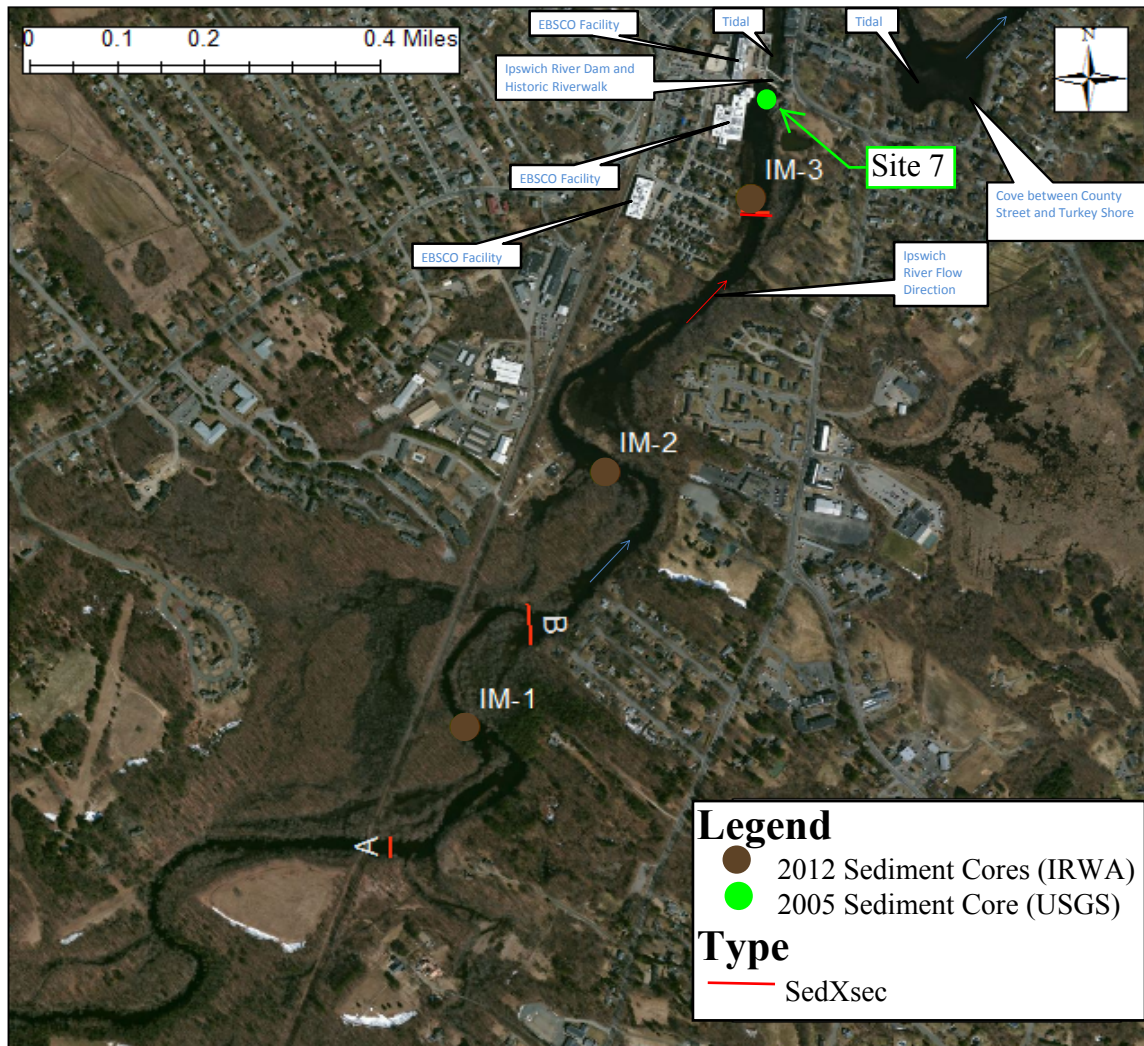
Figure: Sediment core locations and sediment depth cross sections from 2012 surveys of Ipswich Mills impoundme

CSE also believes further sediment testing should be conducted above and below the impoundment with an emphasis on downstream of the impoundment. CSE suggests at least three to four (3 – 4) sample locations downstream of the impoundment, one recommendation being the meander or cove between Country Street and Turkey Shore Road as shown on the Map. A significant volume of sediment from street sanding has accumulated within this vicinity for years including fines from organic matter and possibly discharges from the former mills. This is also likely the location where sediment will accumulate within the tidal waters of the Ipswich River (see Figure for this location).
