South Middleton Dam, Ipswich River
Partial Feasibility Study
Phase I Technical Memorandum

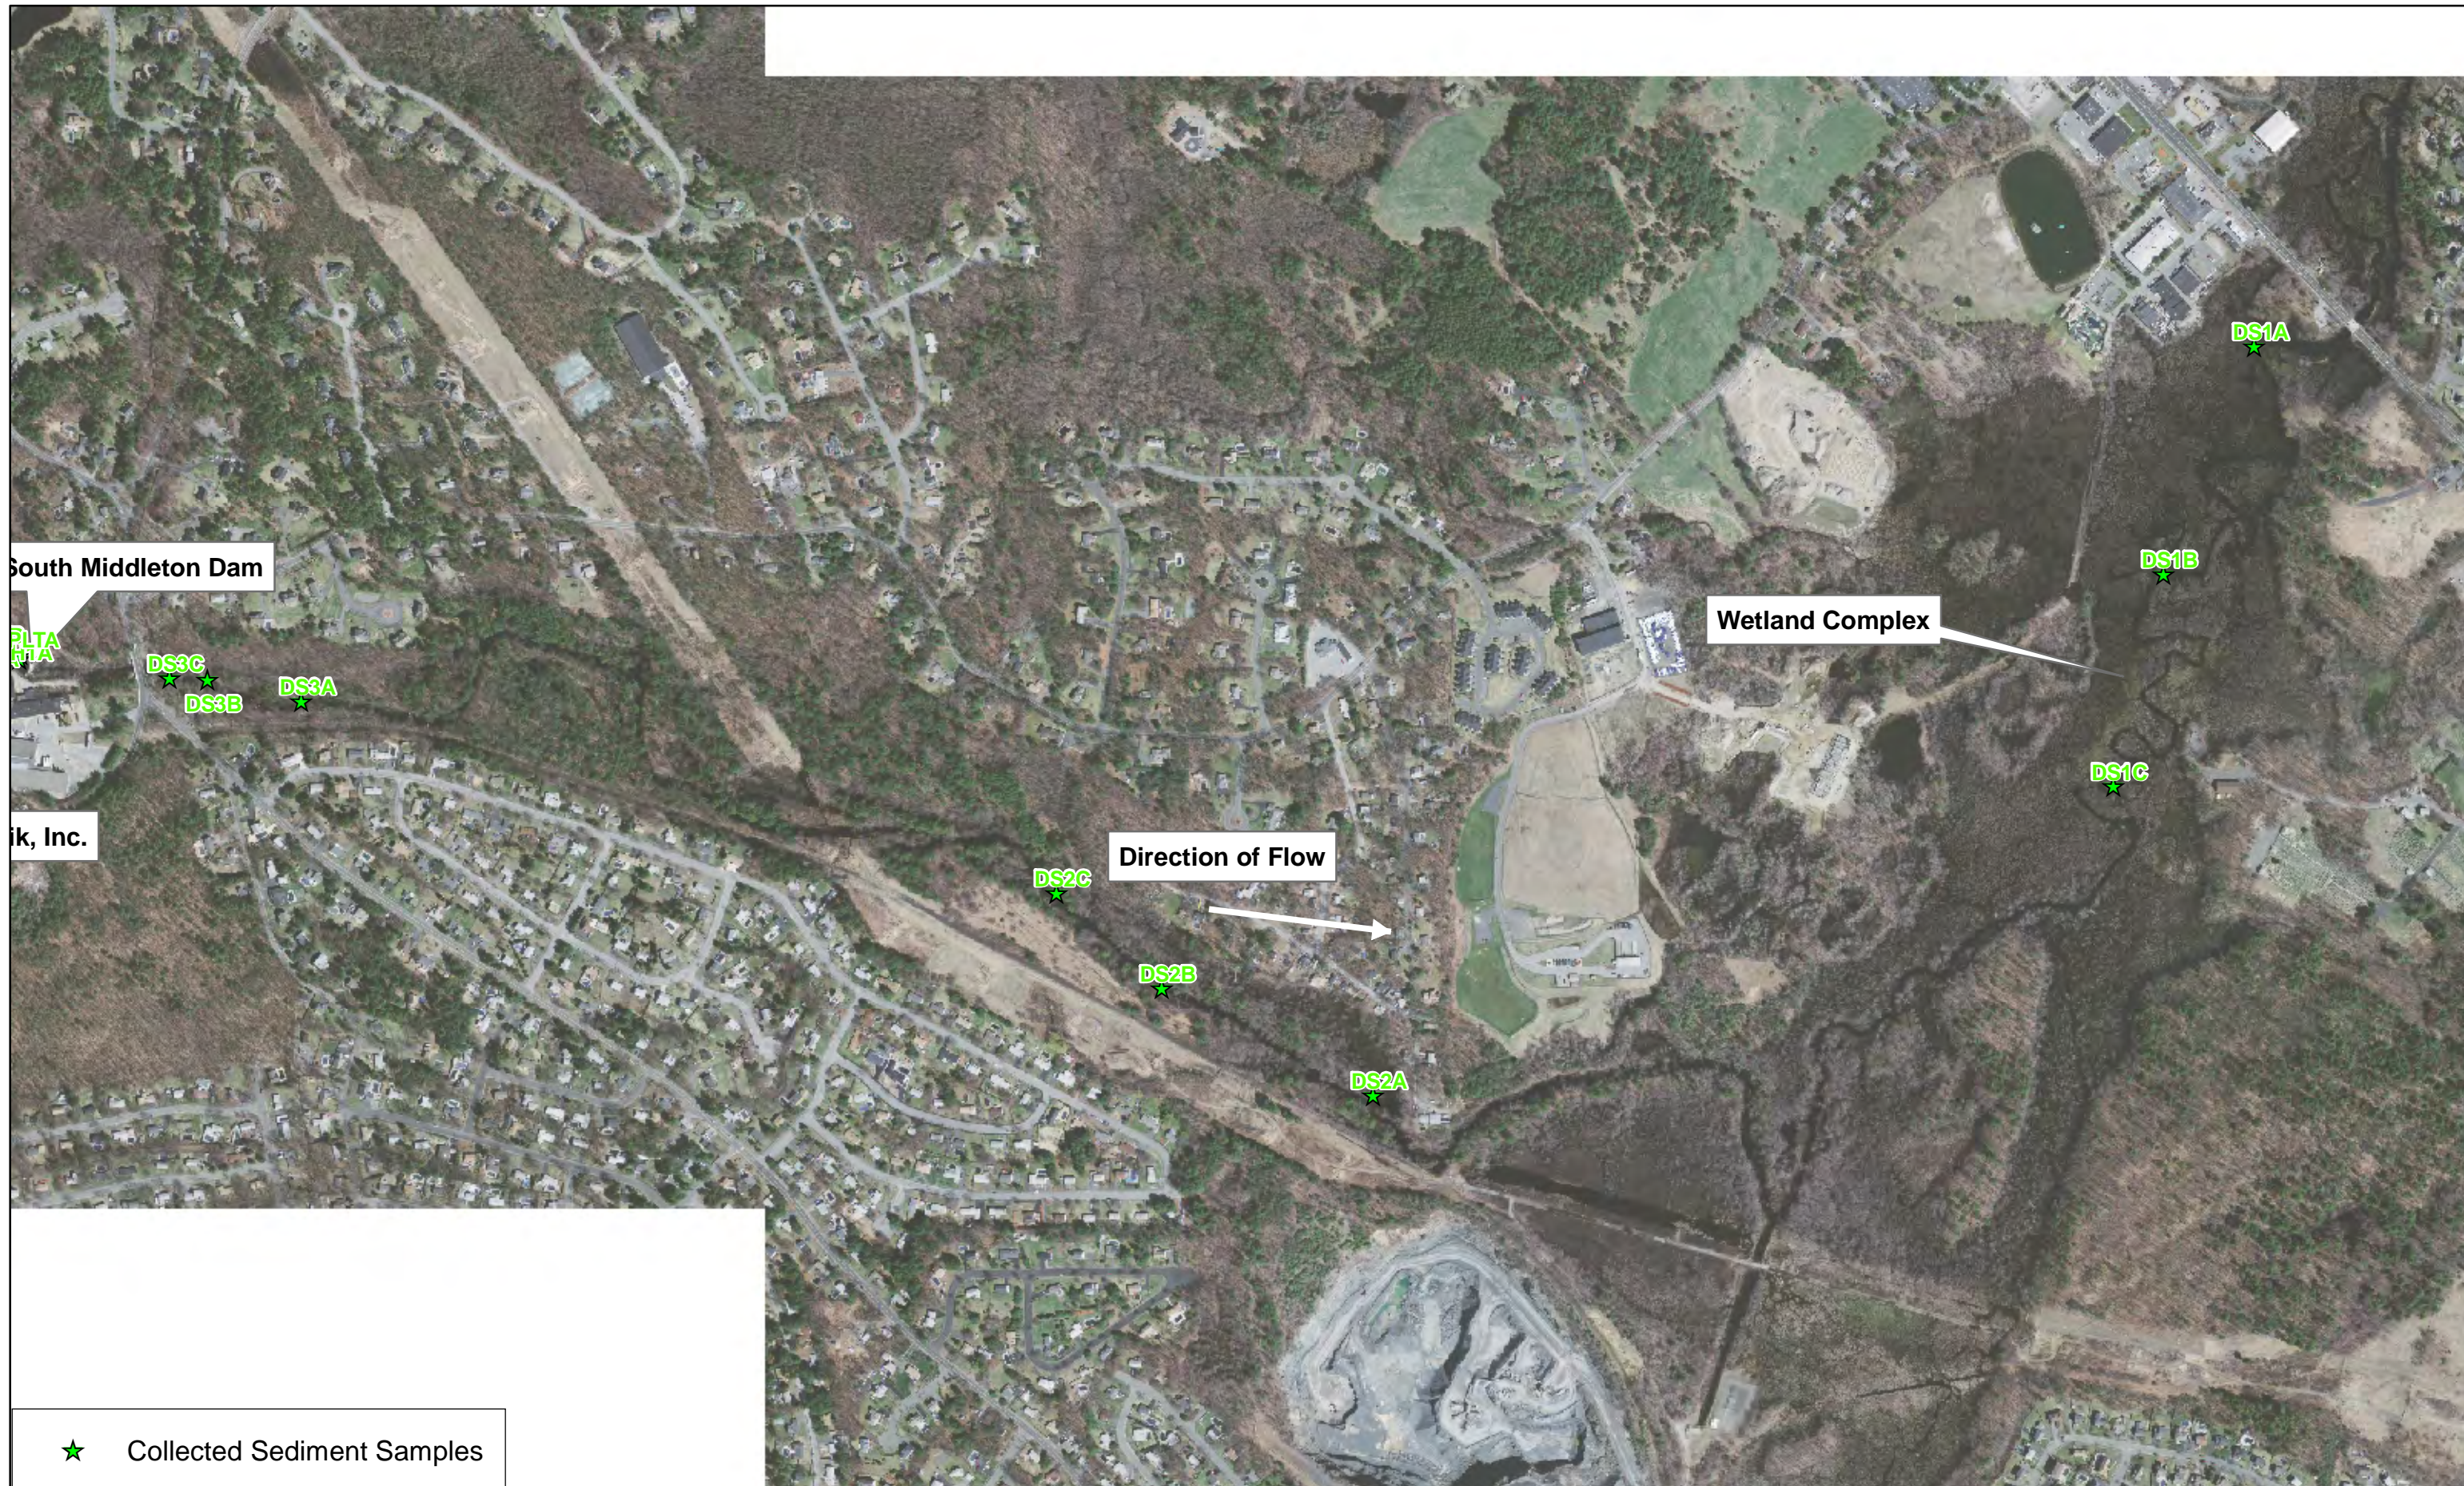
APPENDIX C
SEDIMENT SAMPLING LOCATIONS

★ Collected Sediment Samples

South Middleton Dam
Ipswich River, MA
Sediment Sampling Locations

For this partial feasibility study, Inter-Fluve Inc. collected ten sediment samples around the South Middleton Dam in the spring of 2010. Five samples came from within the impoundment, and these five include two floodplain samples, two samples from the channel, and two samples from the Cove (Appendix C). Two samples are from downstream of the dam, and we did collect a third sample that could be analyzed if necessary. One sample from upstream of the impoundment is included in the analysis. Each sample that has been analyzed is a composite of two or three cores from an area with a similar sediment composition. These individual cores are preserved and can be analyzed to refine the level of contamination at sites deemed necessary. Based on information gathered during our due diligence analysis, we tested the soil samples for metals, SVOCs (PAHs), VOCs, EPH, PCBs, and physical characteristics. We then compared the results to the MCP S-1 and S-2 standards (310 CMR 40.0975(6)(a)) as well as the PEC (probable effects concentration). The S-2 thresholds were used because the land around the impoundment is owned by Bostik, Inc., which is considering limiting use on the property through an Activity and Use Limitation (AUL).
