IPSWICH RIVER
WATERSHED
ASSOCIATION

RiverWatch Water Quality Volunteer Monitoring Program

2011 Annual Results Report

December, 2012

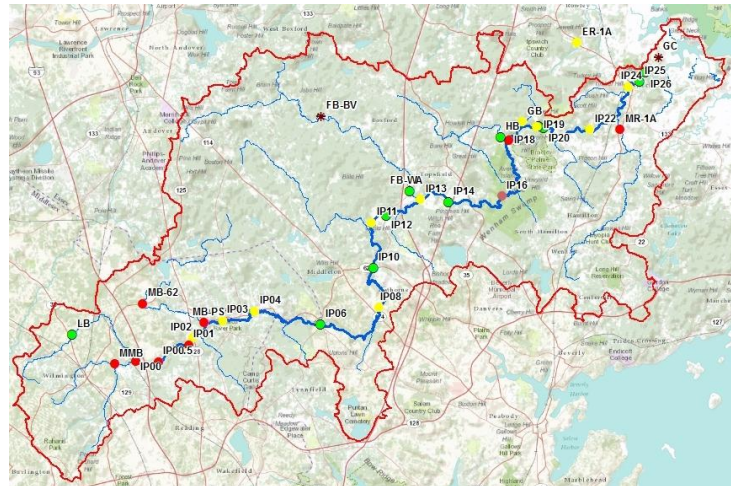
Figure 1. Average summer dissolved oxygen levels for 2011. Sites in red (< 3mg/L) represent a highly stressed environment for fish and other aquatic organisms.

Low DO conditions have been widespread and frequent during the past 15 years of monitoring. In 2011, 22% of samples did not meet the state standard for dissolved oxygen concentration of 5 mg/L. Figure 1 illustrates average summer dissolved oxygen concentration values at all sites. Sites located in the upper section of watershed continue to show a higher degree of impairment for dissolved oxygen than sites elsewhere.

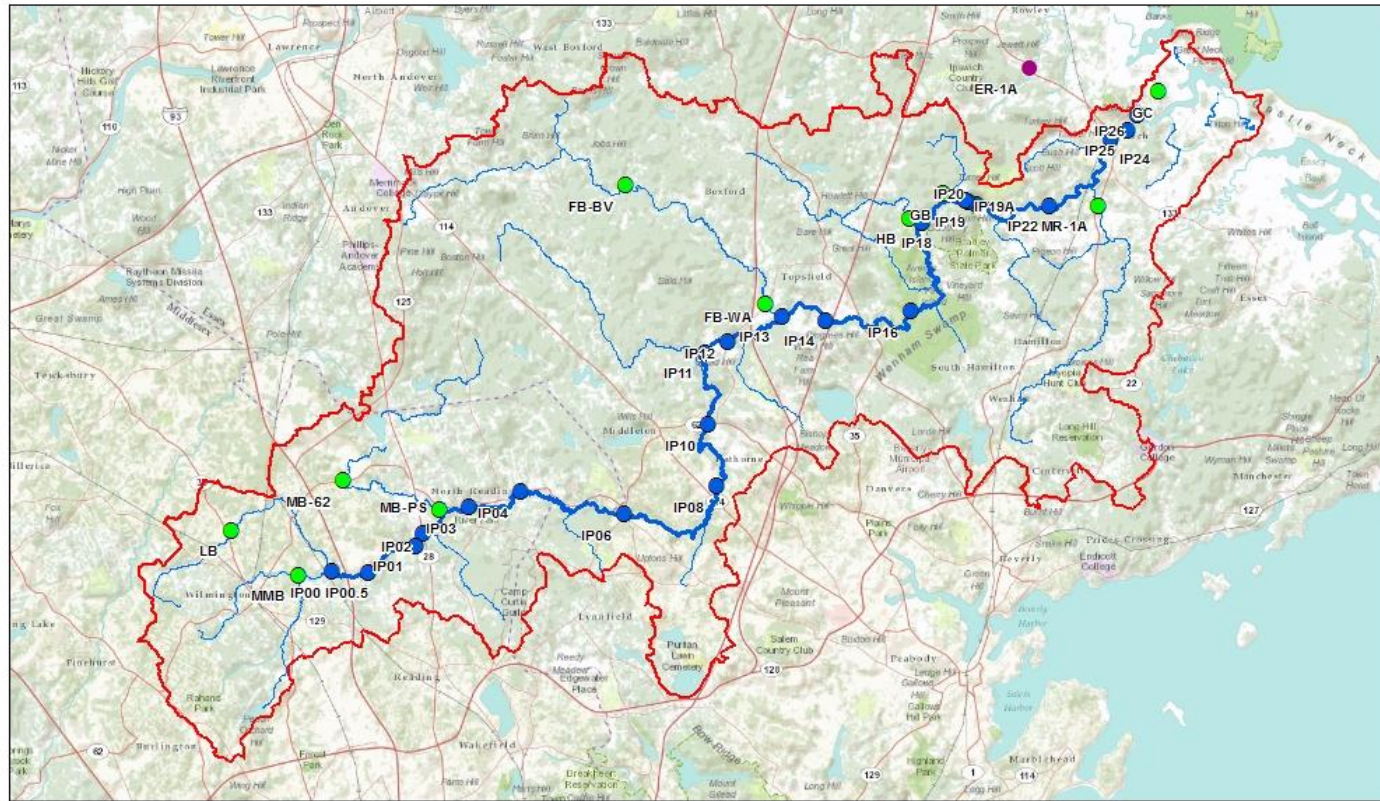
Figure 2. RiverWatch Monitoring Sites

IPSWICH RIVER WATERSHED AND MONITORING SITES

As stated earlier, IRWA has conducted informal monitoring from 1988-1996. The RiverWatch program took its current form in 1997 and has been continuously monitoring the Ipswich River Watershed since this time. In order to best use our resources to gain an accurate picture of the Ipswich River, 9 tributary sites and 21 sites along the mainstem of the River from Wilmington to Ipswich, have been identified for monitoring once a month from March through December. Both Fish Brook at Brookview Farm Rd. (FB-BV) and Greenwood Creek (GC) were discontinued in 2001. In 2011 we added Gravelly Brook in the Willowdale State, Forest, Ipswich and Martins Brook on route 62, Wilmington as two additional tributary sites. We also added the Egypt River on Rt. 1A, a site located just outside the watershed in Ipswich. The Egypt River forms the confluence of Dow Brook and Bull Brook, which is an important sub-watershed for drinking water supply in the town of Ipswich. This was also once an important smelt run and probably river herring. A map of monitoring sites and a list of site descriptions and monitoring parameters are included in figure 2 and table 2.

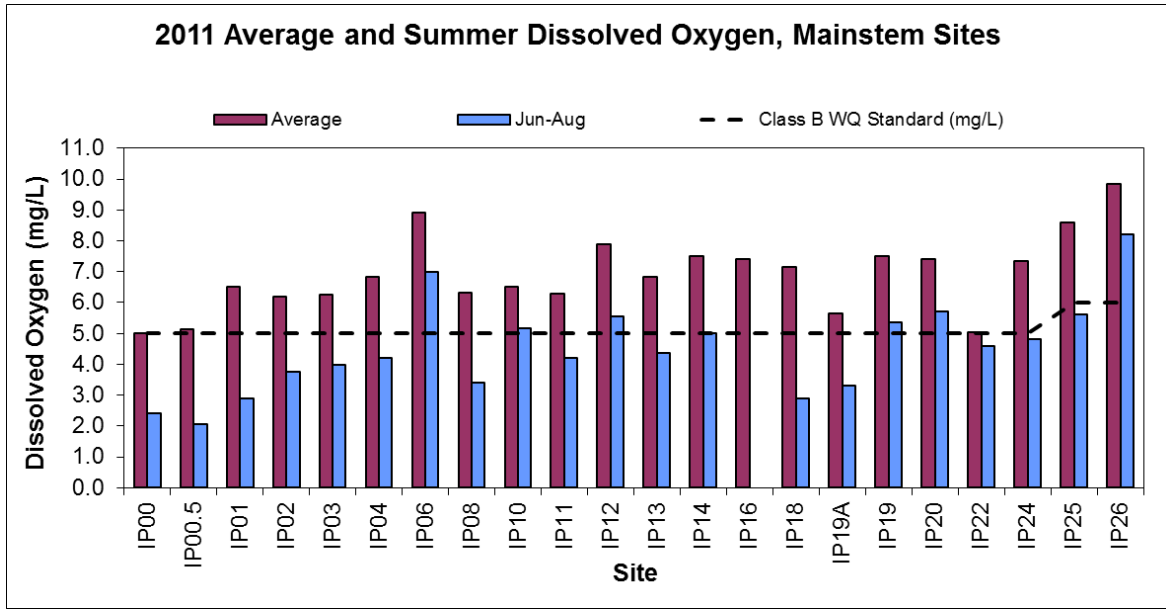
Figure 7. Comparison of average annual and summer dissolved oxygen concentration for mainstem and tidal sites. The dashed line represents the minimum level for class B waters (5mg/L) and class SA waters (6mg/L).

Figures 7 and 8 compare average annual and summer dissolved oxygen concentration for mainstem and tributary sites respectively. Sites IP00 to IP04 all have summer dissolved oxygen levels below 5mg/L.

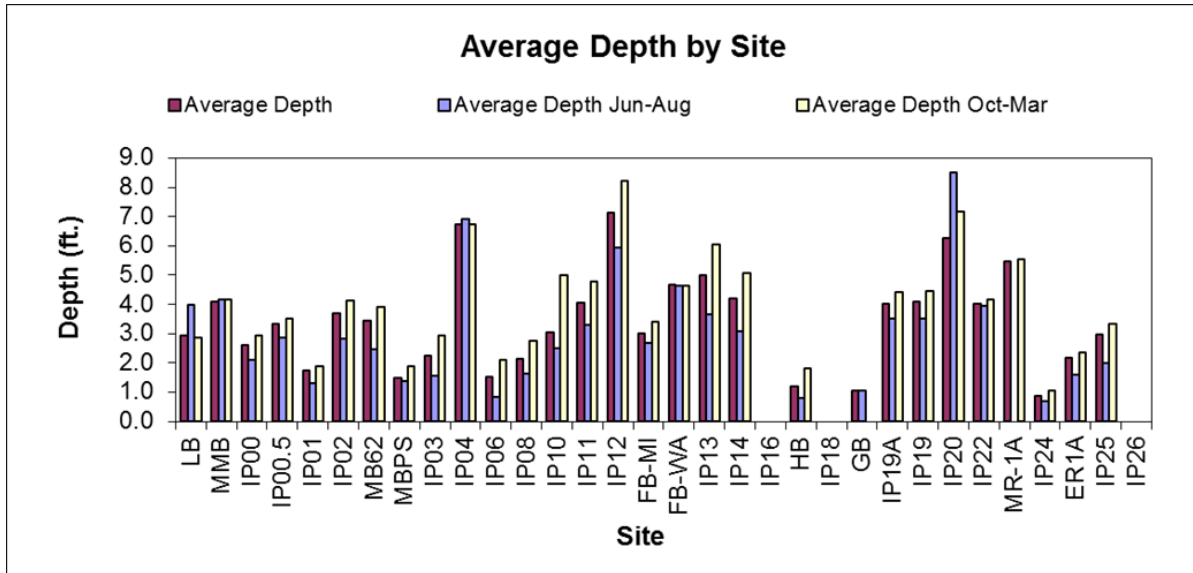
Figure 10: Comparison of average annual, spring and summer water depths by site.

In 2011, most sites recorded water depths consistent between seasons (figure 10). Average summer depth was not drastically lower; in fact, average summer depth was nearly equal to and in some cases, greater than average annual or spring water levels. This was due to precipitation being at or above normal most months of the year. August was especially wet, with 303% the normal rainfall recorded in the northeast region of Massachusetts (Table 6).

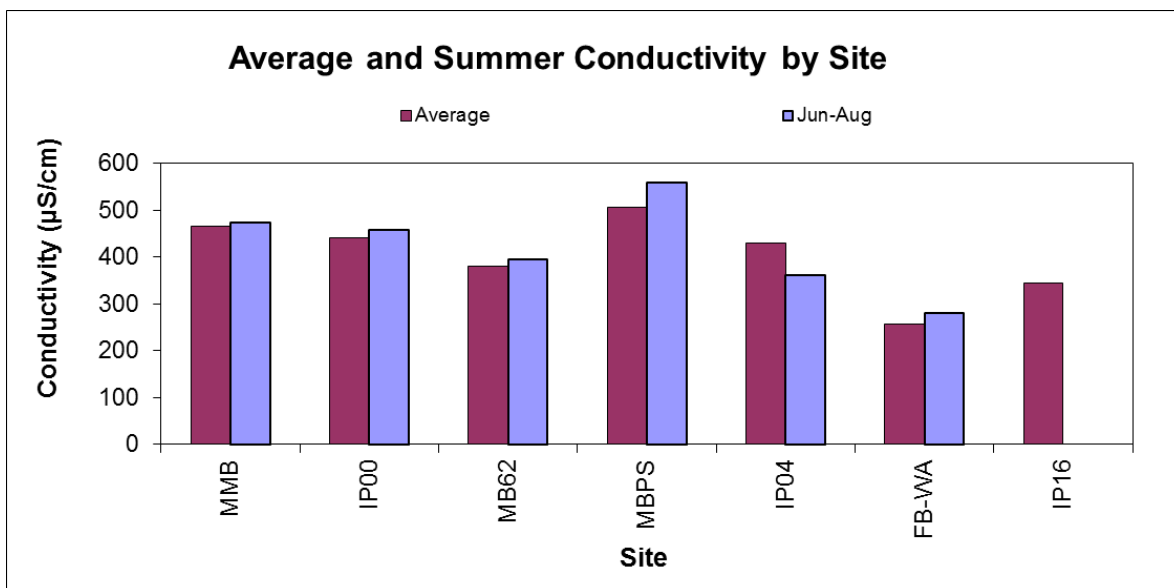
Figure 18 Annual and summer average conductivity by site. The normal range for conductivity is 150-500 µS/cm (micro Siemens per centimeter).
