Cape Cod Atlas of
**Tidally Restricted
Salt Marshes**

Cape Cod, Massachusetts

Conducted & Prepared by
Cape Cod Commission
for the
Massachusetts
Wetlands Restoration Program

December, 2001

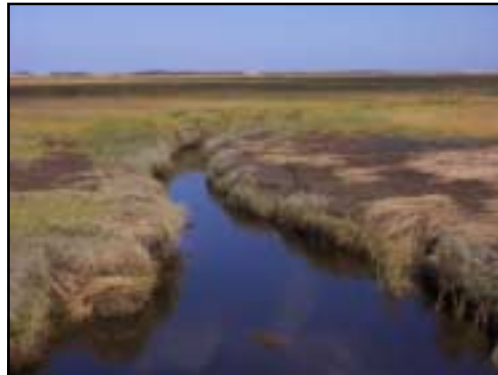
Severe vegetation die off observed in Barnstable, at site BA-2.

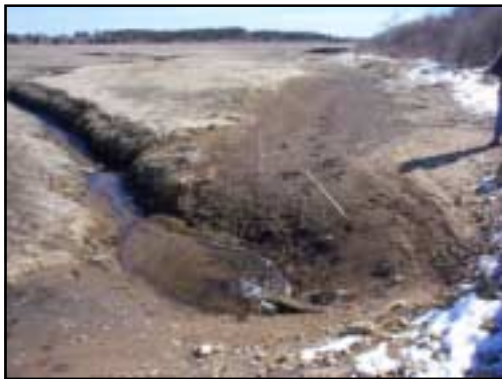
An example of a major scour pool and vegetation die off observed in Brewster at site BR-2.

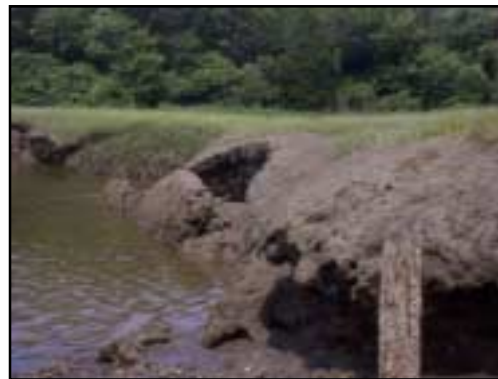
Marsh slumping and vegetation die off observed in Sandwich, at site SA-10.

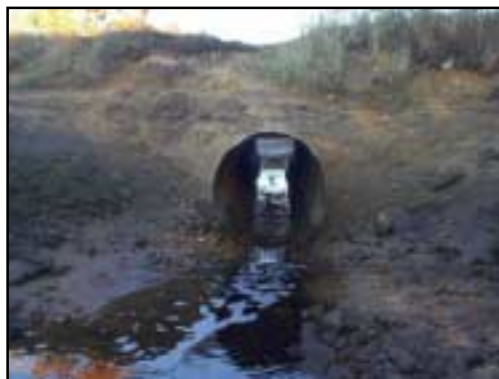
Major erosion observed in Yarmouth, at site YA-4.

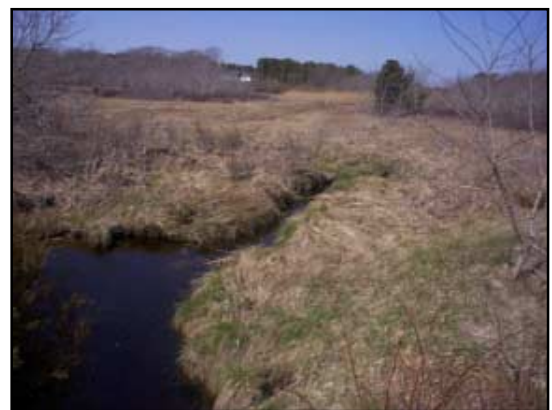
The upstream affected seen here is scattered with cattails, shrubs, trees, and *Phragmites*.

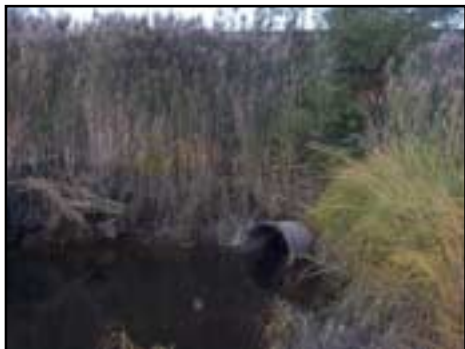
The upstream pipe opening, while not clogged or broken, is dwarfed by the pool of water attempting to pass through it.

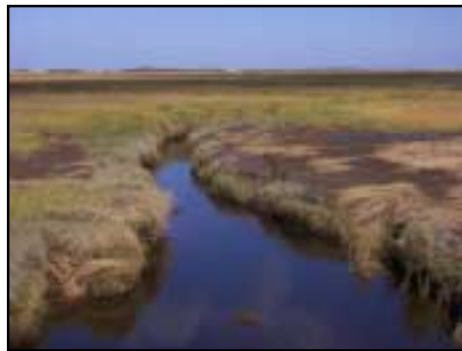
Bridge Creek is 10-15 feet wide both seaward and upstream of the restriction. Visual indicators of restriction on the seaward side are severe and include marsh slumping, vegetation die off, ponded water, *Phragmites*, a wide scouring basin, and major bank erosion. The affected area between sites BA-2 and BA-3 is also degraded. Scour, bank erosion, and *Phragmites* are all present.

Looking seaward over the salt marsh, vegetation die-back and bank erosion are clearly visible near the restriction.

A 4 by 8-foot box culvert under site BA-2 in conjunction with the existing Route 6A culvert would provide partial restoration of tidal flow (ACOE, 1996, pp. 34-35). This site is currently being studied by the Massachusetts Wetlands Restoration Program for potential restoration in the near future. To date restoration discussions do not include work at upstream site BA-3.

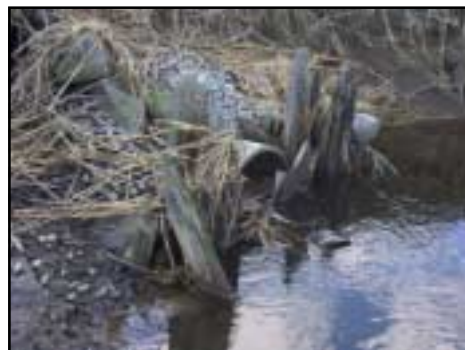
The seaward culvert opening is clogged with debris, blocked by the eroding retaining wall, and inadequately sized.

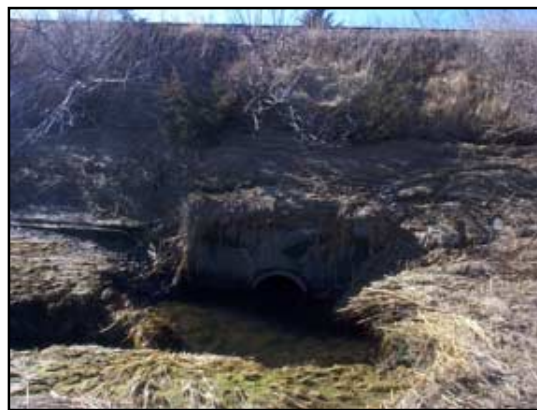
The seaward culvert opening, with the high-tide line evident well above it, is scarred by major scouring and bank erosion.

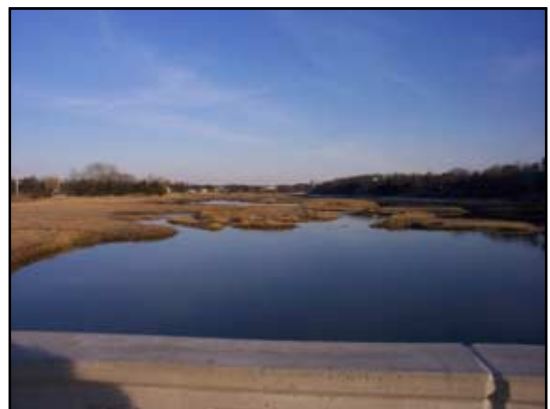
View looking upstream over Maraspin Creek; water pools and then flows upstream via several smaller channels through the marsh.

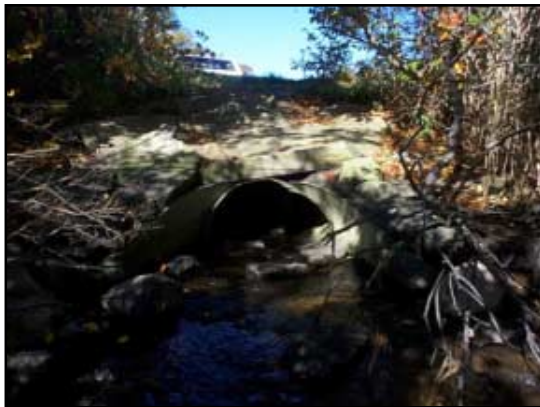
Upstream view of the Commerce Road culvert, which has been misshapen by the weight of this concrete top layer.

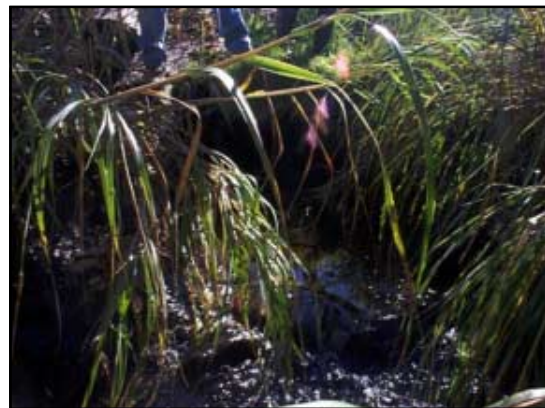
The seaward side of culvert under Commerce Road is nearly obscured by the *Phragmites*.

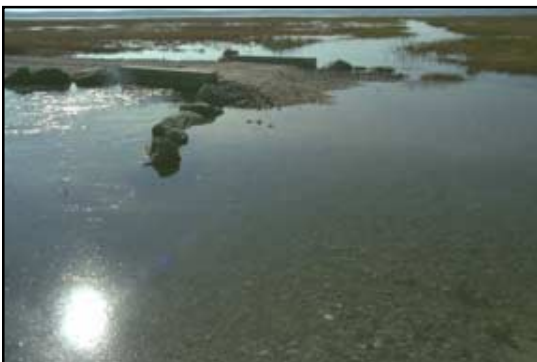
Both the seaward and upstream channels are approximately 10 to 15 feet wide. Rock retaining walls attempt to keep the jeep trail from washing out around the culvert, however scouring and erosion are present at the site.

High tide at site BA-7, which regularly floods the jeep trail.

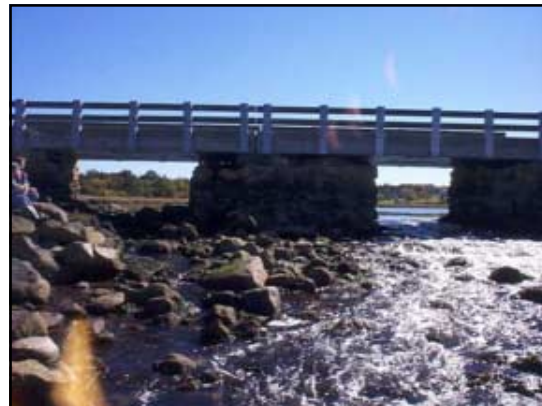
Water is detained upstream in Halletts Mill Pond due to rocks built up in the streambed underneath the Keveney/Mill Lane Bridge.

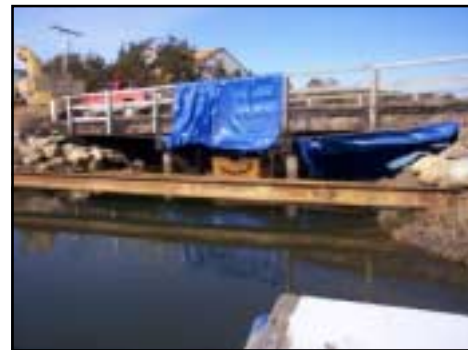
Reconstruction of the bridge began in the fall of 2000. The project is intended to widen the bridge and increase its height above the Santuit River. Unfortunately, reconstruction did not include increasing the width of the span to allow increased tidal flow.

Construction underway on the Santuit River bridge to widen and raise the roadway; unfortunately plans do not include alleviating the restriction.

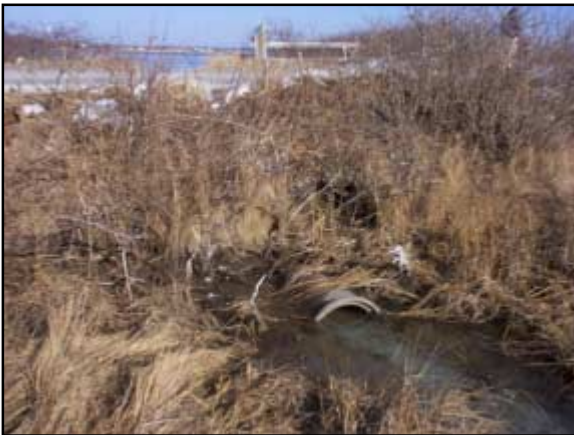
A channel, 2 feet wide and approximately 20 feet long, connects the seaward opening with East Bay. The upstream channel is also 2 feet wide. Restriction is evidenced by minor erosion on the upstream banks, minor scour in the channel bed, and a large scouring basin on the seaward side. *Phragmites* dominates the vegetation toward the back edge of the affected area.

The upstream pipe opening is nearly submerged and erosion has exposed much of the pipe.

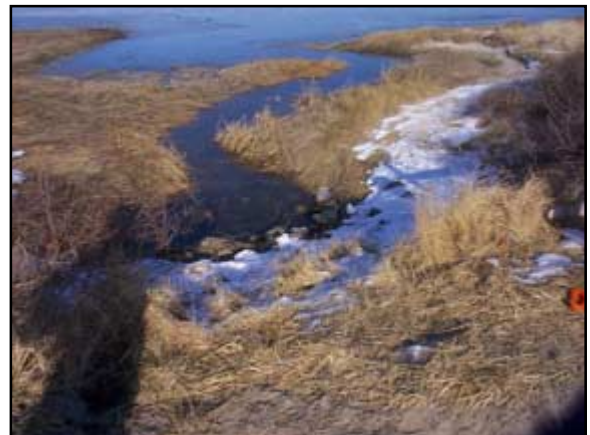
Stones cover the spot where the seaward opening is believed to be located; a short channel opens into East Bay.

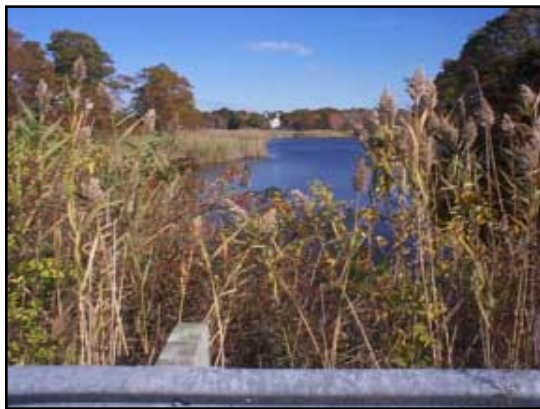
A 20-foot wide, 100-foot long, channel connects this culvert to the Bumps River. Visual indicators of a restriction include significant scouring and minor bank erosion near the seaward opening. Upstream, minor erosion is evident. Flow does not appear to be fast and frequent enough to scour the area. The vegetation change is dramatic—seaward, salt marsh exists and dominates, while upstream of Bay Lane *Phragmites* dominates.

Phragmites dominates the view and the vegetation in the upstream affected area.

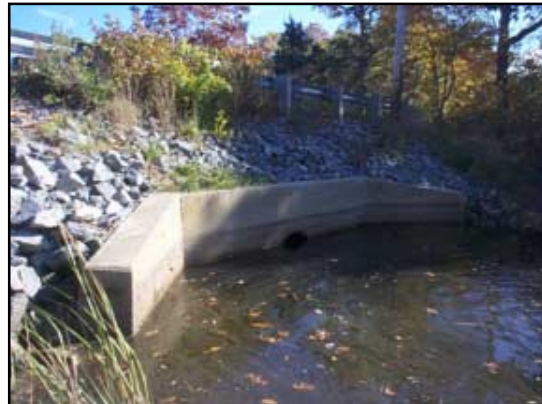
Water pools at the seaward side of the culvert under Bay Lane as high tide approaches.

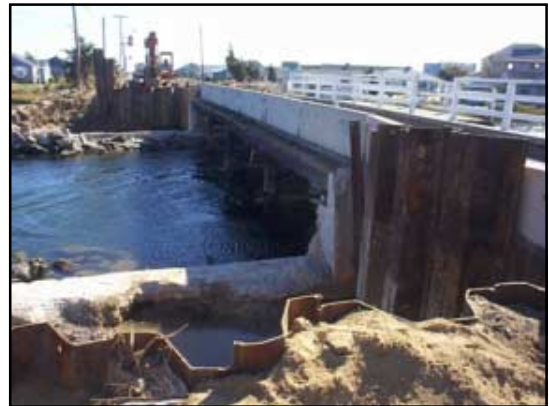
The Craigville Beach Road bridge undergoing reconstruction in the fall of 2000.

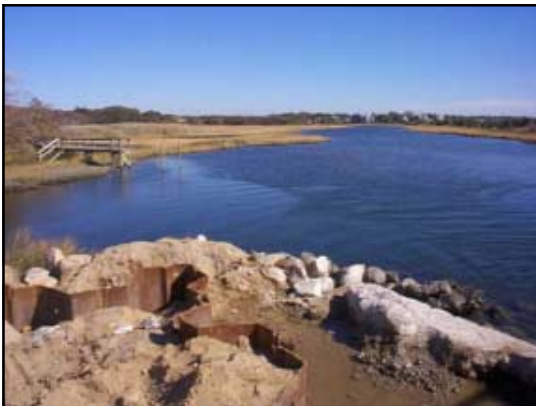
Salt marsh lines the banks of the Centerville River upstream of the Craigville Beach Road bridge.

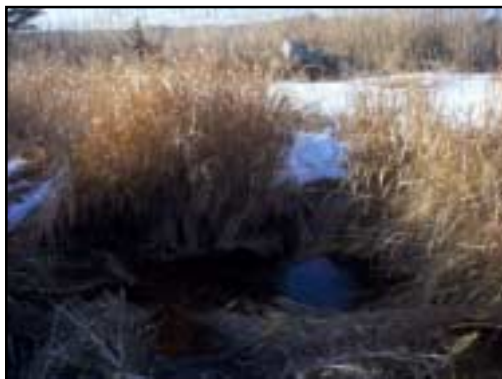
The seaward channel is approximately 5 feet wide and actually widens upstream where it varies between approximately 5 and 10 feet. Visual indicators of a restriction include minor pooling, scouring basins, and erosion on both the seaward and upstream sides. Small stands of *Phragmites* are also found at the both ends of the culvert. No water was observed to be flowing through this pipe.

Upstream end of culvert, with seaward side in background.

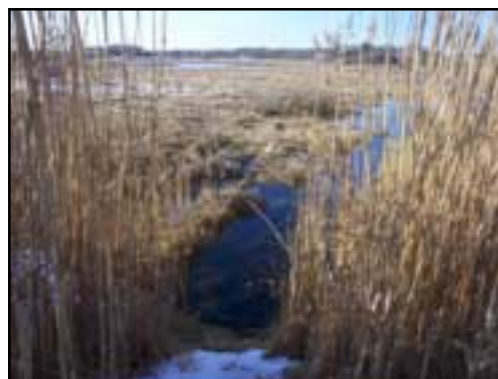
*View from the culvert into the Centerville River and salt marsh beyond; a narrow stand of *Phragmites* lines the roadway near the pipe.*

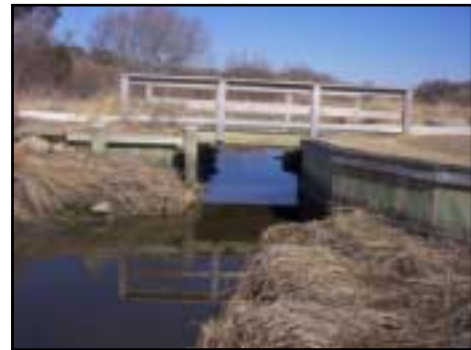
The stream channel is approximately 15-20 feet wide seaward narrowing to 10-15 feet wide upstream of the bridge. By the time the channel reaches upstream site BA-16 it has broken into smaller channels ranging from 2 to 10 feet. Minor bank erosion and vegetation die off occur on both sides of the bridge, and a slight scouring basin is present on the upstream side. There is also minor surface ponding on the upstream side.

Seaward side of wooden bridge over Halls Creek with the tee-off area protruding into the channel on the right. Vegetation die off and bank erosion scar the creek banks.

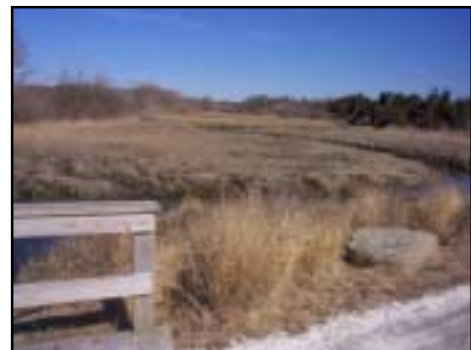
When looking upstream from the bridge across the affected salt marsh the berm of site BA-16 is visible in the distance.

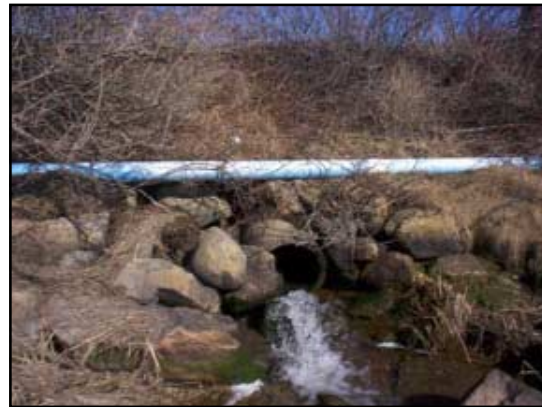
This 20-inch opening moves water from the upstream pond seaward through the downstream salt marsh of Halls Creek.

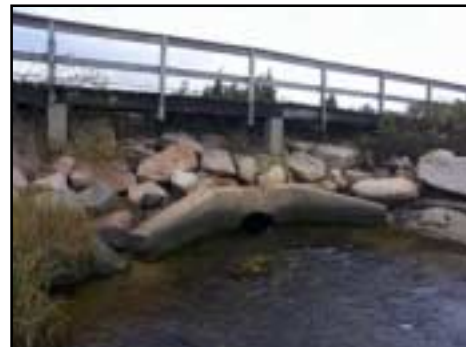
Seaward side of the Ocean Avenue culvert viewed from Keyes Beach. High water marks appear above the top of the culvert opening.

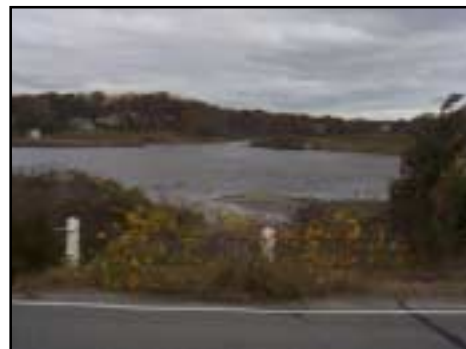
Looking upstream from Ocean Avenue into the Stewart's Creek marshes. *Phragmites* is visible all along the heavily developed shoreline.

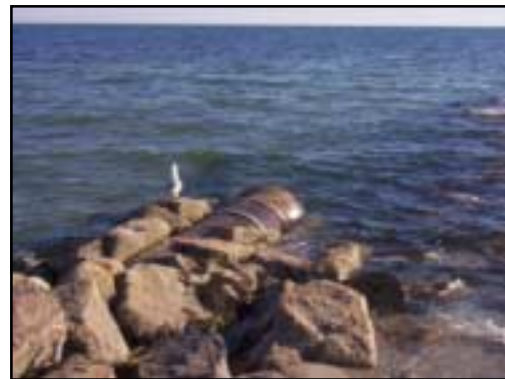
The seaward side of the pipe, seen under this stone jetty, opens directly into Hyannis Harbor.

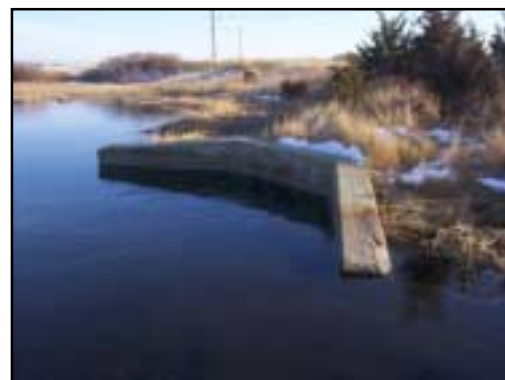
Concrete wing walls frame the culvert opening on the upstream side, submerged here at high tide.

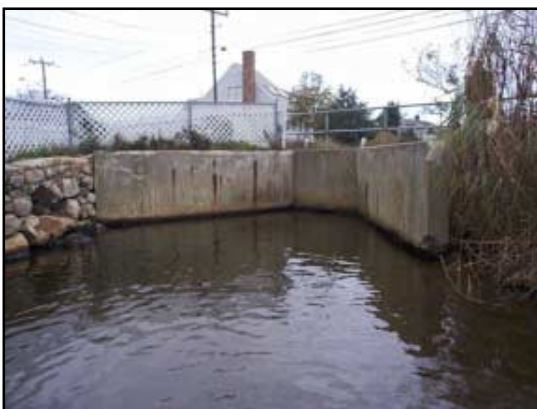
Seaward, the creek is approximately 30 feet wide. The upstream channel is short, and becomes an open pond approximately 100 feet beyond the culvert. A minor stand of *Phragmites* is present near the upstream opening. Other evidence of tidal restriction includes a minor scouring basin and vegetation die-off near the seaward opening.

Concrete retaining walls channel Snows Creek into a 3-foot opening, submerged here at high tide.

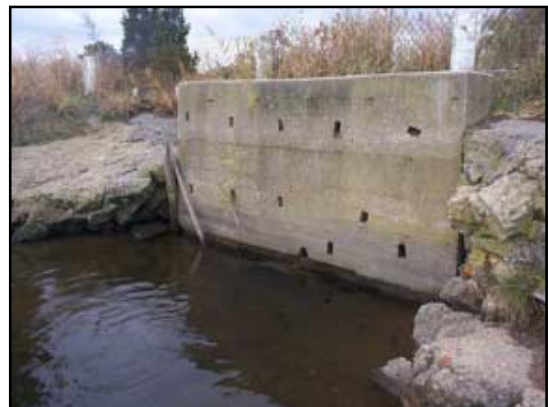
Concrete headwall on the seaward side of Snows Creek obscures the culvert opening below the water surface.

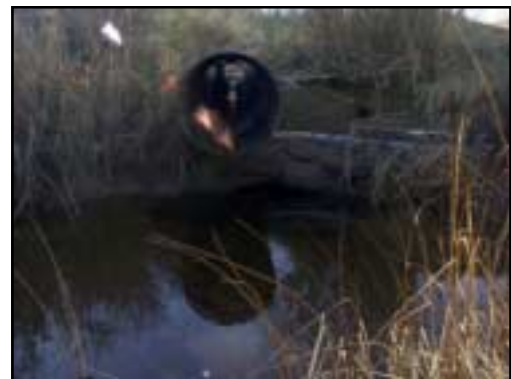
This corrugated metal pipe is suspended high in the bank but does pass water regularly. Water also flows through an obscured opening below this water line.

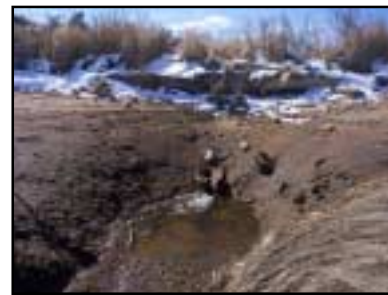
Bank scouring is severe as water pools by the seaward side of this restrictive cranberry bog berm; boards form a casing around the tiny, 6 inch pipe.

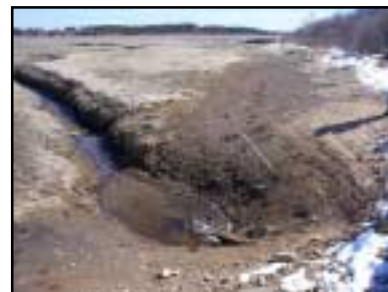
Scour, erosion, and vegetation die-off are severe in the seaward salt marsh adjacent to site BR-2.

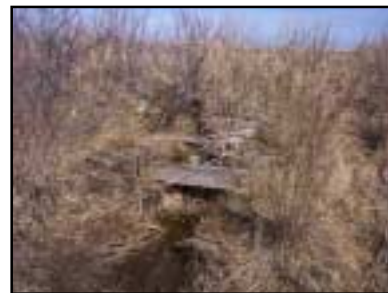
The upstream opening of the 6-inch pipe is barely visible under the heavily eroding wooden retaining wall.

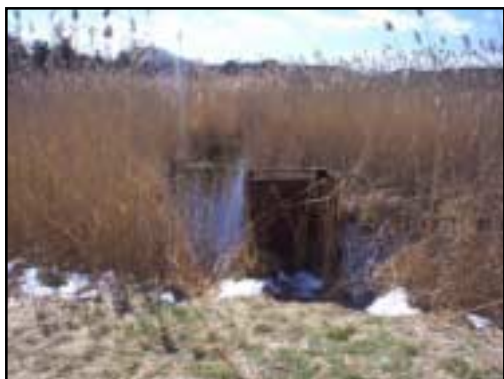
The pipe is set approximately 4 feet below the upstream dam structure, effectively preventing any incoming tidal flow from rising up and out of the pipe to naturally flush the upstream affected area. The upstream affected area is dominated by *Phragmites*. Water is pooled around the dam structure upstream; currently no stoplogs are in place and water is constantly draining from this area. The seaward channel (estimated width averaging 4 feet) is approximately twice the width of the 2-foot pipe. There is a flapper valve stuck in place, open only 5 inches.

Metal dam structure in the Phragmites-dominant marsh upstream of the old cranberry bog berm (now a footpath).

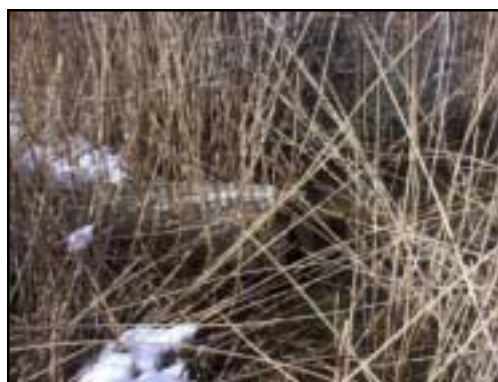
Corrugated metal pipe with flapper gate visible through the Phragmites at the seaward opening of BR-3.

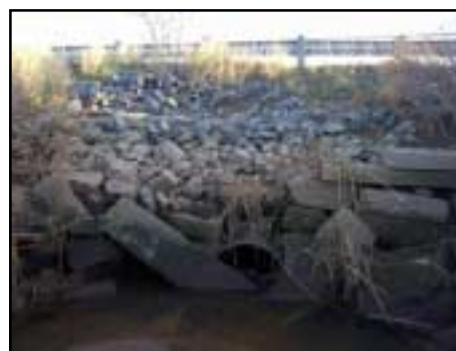
The seaward culvert is visible at low tide with water pooling by this partially blocked opening.

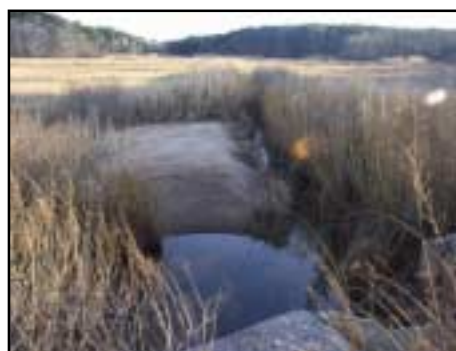
A large sandbar has formed in the upstream channel near the culverts' scour basin – road runoff from the nearby major road junction is a likely source.

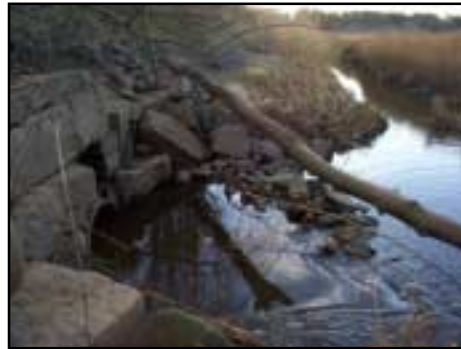
This headwall supporting the upstream opening is in need of repair—it is eroding and falling into the channel below.

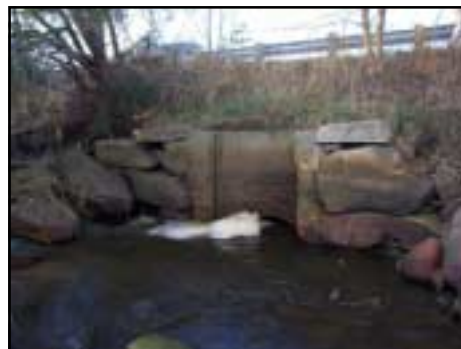
The seaward opening is nearly submerged even well before the tide is high. Watermarks are visible near the top of the headwall.

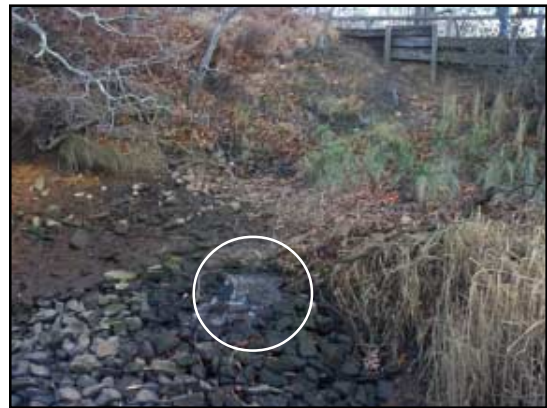
An eroding retaining wall helps support the Cape Cod Rail Trail that is restricting tidal flow in Namskaket Creek – water is seen bubbling out from under a pile of rocks that covers the 1-foot pipe.

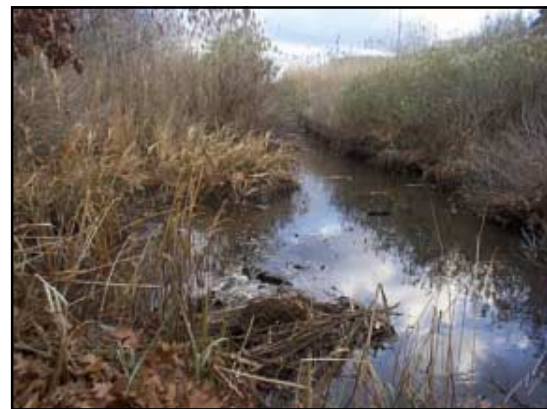
Phragmites and shrubs are seen taking over the once salt marsh upstream of the Rail Trail.

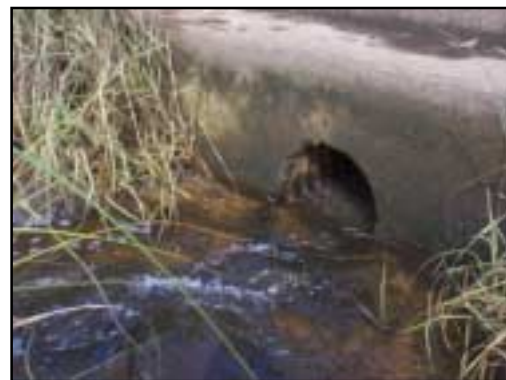
This 16-inch corrugated metal pipe set in the concrete headwall passes the flow of the Red River under Deep Hole Road.

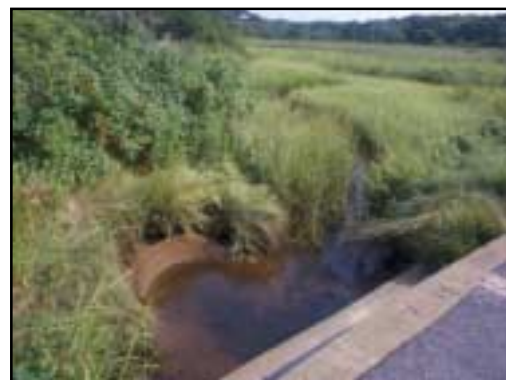
Visual indicators in this upstream affected marsh include a small scour pool near the pipe opening and significant growth of *Phragmites* and cattails.

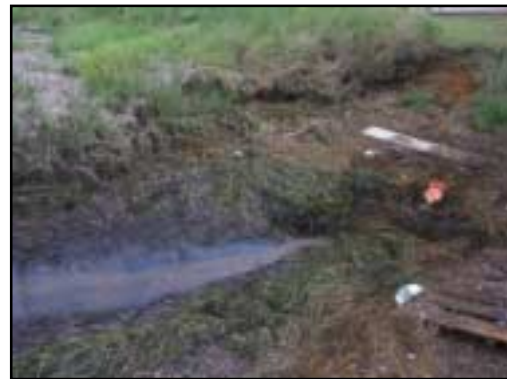
Water trickling out of a mound of dead seaweed near the seaward opening enabled field staff to dig out the opening of the 10-inch pipe. Erosion is a serious problem near the opening.

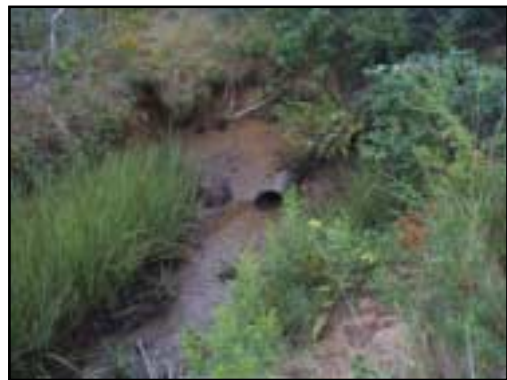
This 10-inch metal pipe passes tidal flow under Chatharbor Lane. Erosion is eating away at the roadway berm.

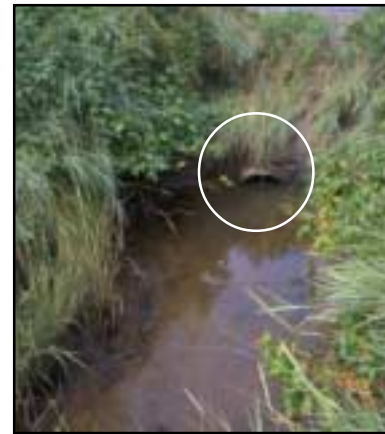
The metal pipe, barely visible above the water line, is set in the steep berm of Ridgevale Road.

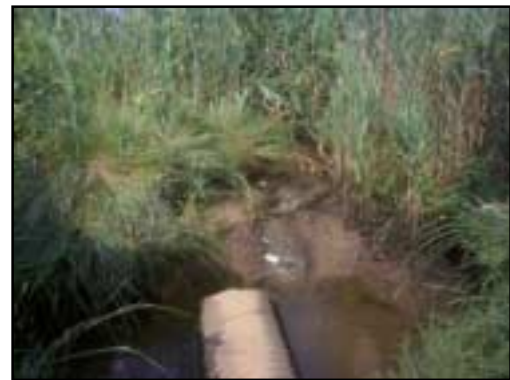
The pipe to the west of the road sits in this scour-pool of stagnant water. *Phragmites* dominates the vegetation around it.

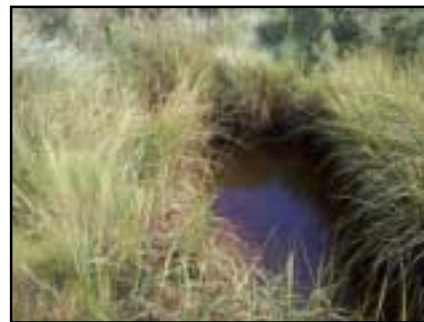
This pool of water submerged the 18-inch opening on the seaward side of Cranberry Lane.

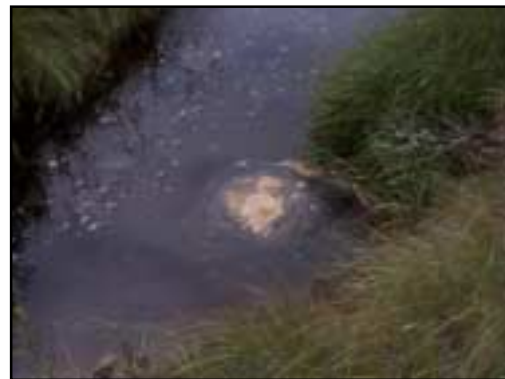
This bubbling pool of water marks the spot where one of the three pipes discharges seaward of Route 28.

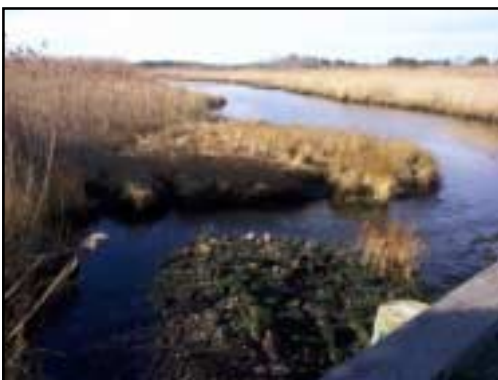
*This view into the upstream affected area shows that *Phragmites* has taken hold in much of the salt marsh and shrub swamp.*

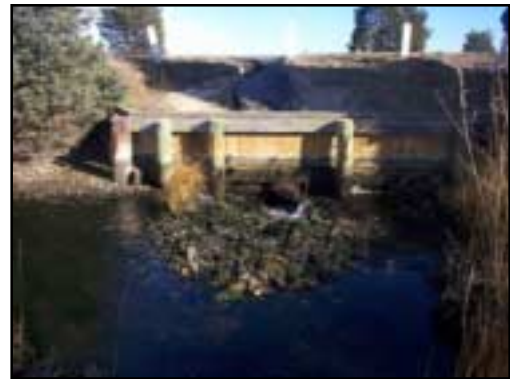
This retaining wall supports the berm of Bridge Street and the 2-foot metal pipe. Rocks are built up in the creek bed in front of the culverts' upstream opening.

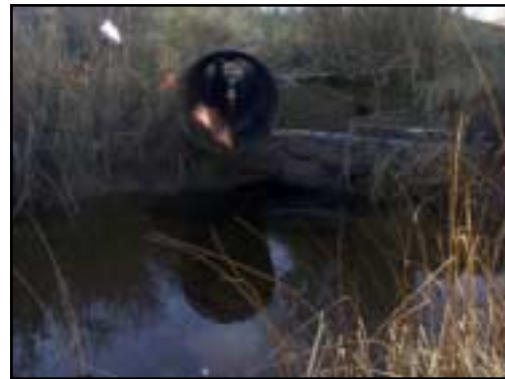
This corrugated metal pipe is suspended high in the bank but does pass water regularly. Water also flows through an obscured opening below this water line.

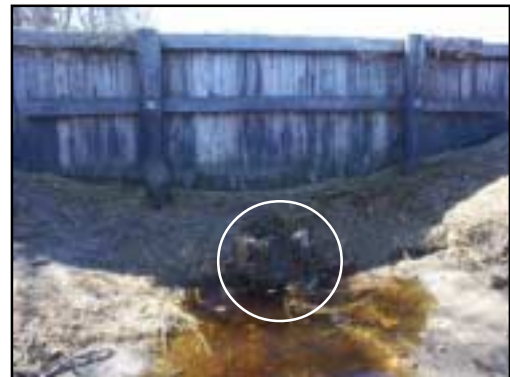
This flapper gate blocks a 16-inch seaward pipe opening, set low in this 10-foot high wooden retaining wall. Erosion and scour undermine the dirt berm of Wheatfield Lane and scar the tidal channel.

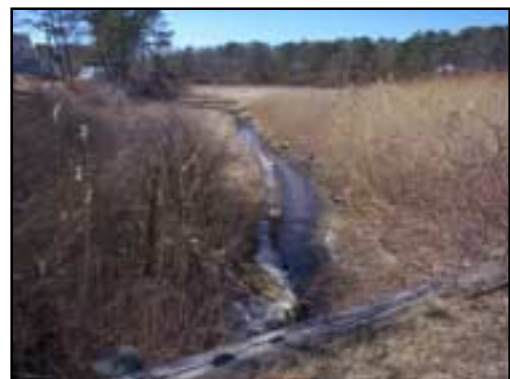
This narrow upstream channel travels between significant stands of *Phragmites* that are overtaking this upstream affected area.

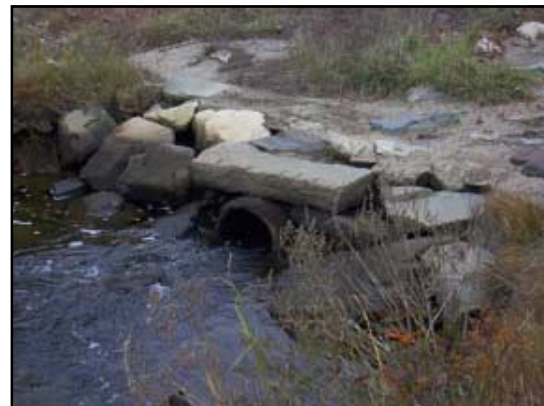
This 2-foot culvert opening passes flow under Fisk Street between Weir Creek and Kelleys Pond.

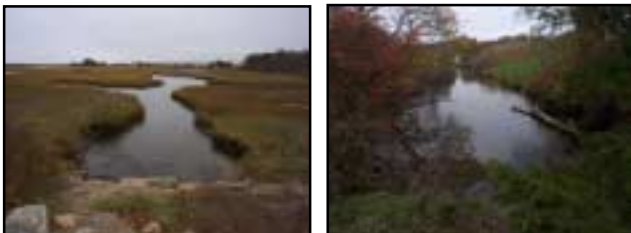
As evidenced by these two photographs, the vegetation changes significantly from the seaward (left) to upstream (right) sides of the Fisk Street tidal crossing.

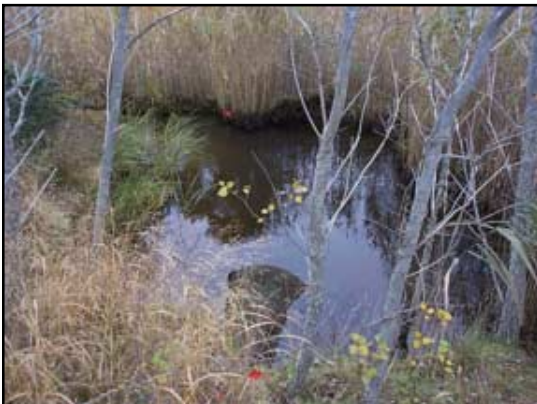
Upstream of the road the pipe juts out into Weir Creek beyond the edge of the roadway berm thereby increasing the necessary length of this restriction by about 10 feet.

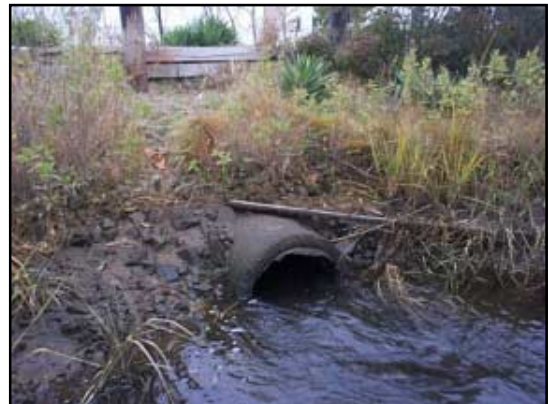
This 2-foot concrete and metal pipe passes the flow of the 5 to 10-foot channels of Weir Creek under Lower County Road.

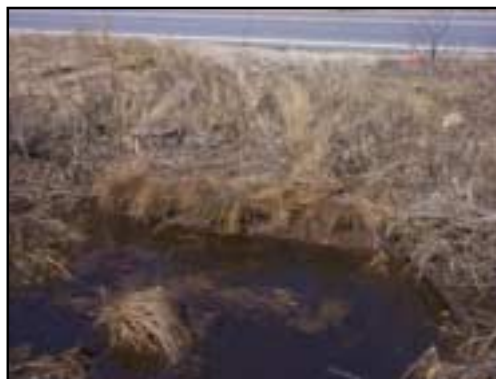
The seaward channel stops abruptly at the roadway berm. Flow does not appear to be moving through the 16-inch culvert that is visibly blocked by debris and silt.

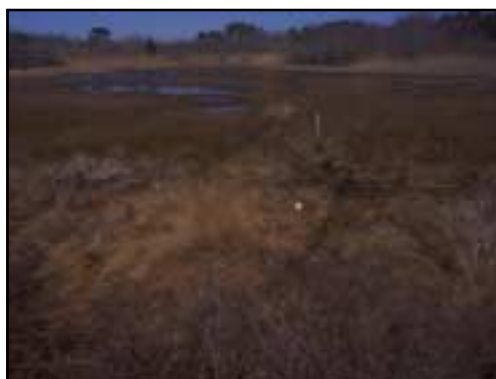
This upstream affected salt marsh is not fed by a measurable channel. *Phragmites* fringes the patch of marsh and water is ponding and flooding the surface.

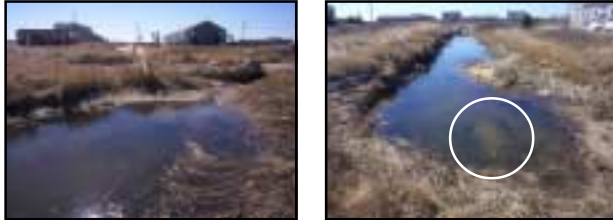
Baker Beach Road Site DE-7

- Restriction width – 2 feet
- Restriction length – 75 feet
- Condition – fair, submerged at mean high tide

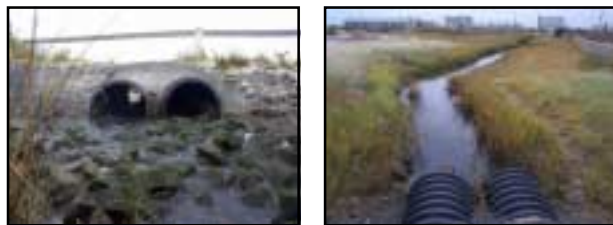
South Village Road Site DE-8¹

- Restriction width – 5 feet (2 at 30 inches)
- Restriction length – 40 feet
- Condition – excellent (appears new)

¹Photos at site DE-8 were not taken the same day, or under the same tidal conditions, as other site photos. Therefore the lower water level observed in the channels does not correlate to levels observed in the other photos of this series. DE-8 was photographed during a low, outgoing tide. All other site photos were taken during a mid to high, incoming tide. Further investigation is needed.

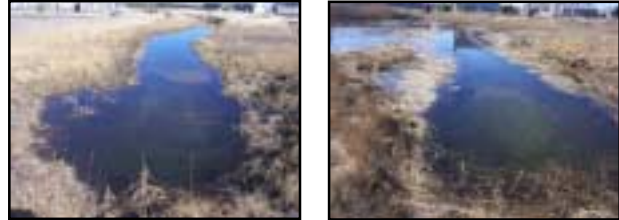
Earthen berm Site DE-9

- Restriction width – 2 feet
- Restriction length – 27 feet
- Condition - fair

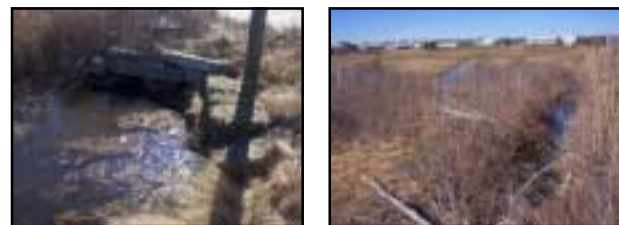
Laynard Lane to Fiddlers Green Lane Site DE-10

- Restriction width – 20 inches
- Restriction length – 235 feet
- Condition – fair

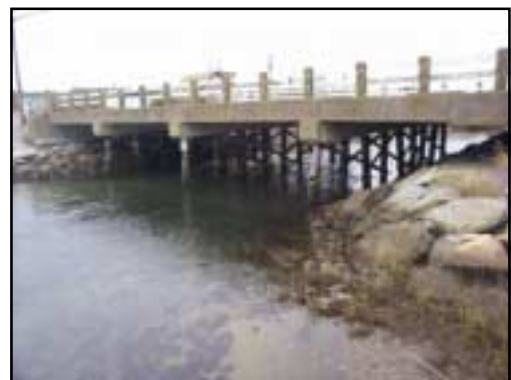
The seaward and upstream river channels are both approximately 80 feet wide. Visual indicators of a restriction include minor scouring and significant erosion seaward, and minor scouring and erosion upstream of the bridge. Minor vegetation die off is also visible. *Phragmites* was not observed in the upstream affected area near this restriction.

This 58-foot bridge span carries the traffic of Lower County Road across the Swan Pond River.

As the seaward restriction on the Swan Pond River any remediation work at this site will need to include study, and likely necessitate work, at the two upstream infrastructure crossing. Presently, restriction intensity diminishes as you move upstream along Swan Pond River. Site DE-g does not exhibit signs of restriction, however, it is critical to note that the flow reaching that site is diminished by the restriction at this site and site DE-12.

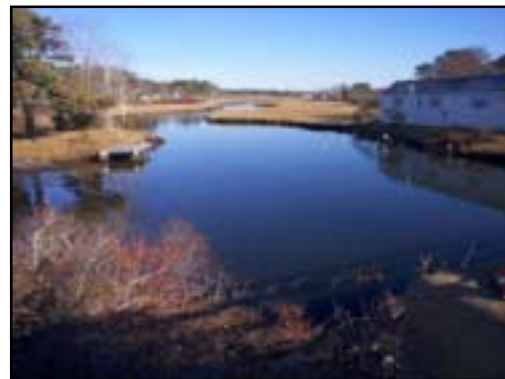
Salt marsh lines much of the upstream banks, however low-lying development is also scattered along the banks of Swan Pond River.

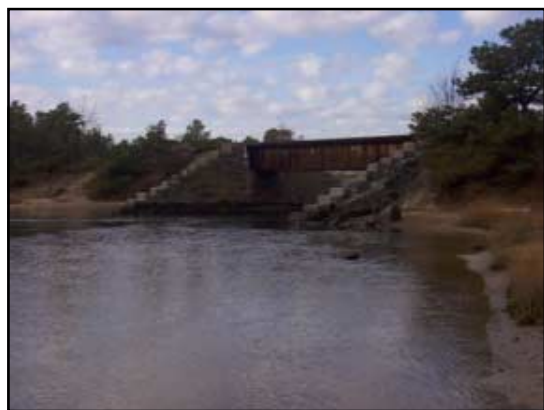
The now unused railroad bed is seen restricting the Bass River, only allowing water to flow through a 63-foot opening.

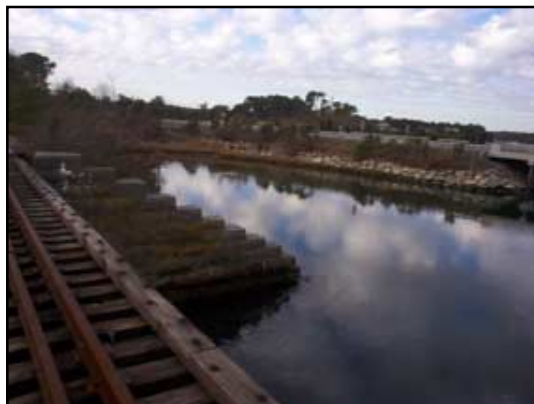
Water pools between the railroad bed and Route 6 causing bank and riverbed scour.

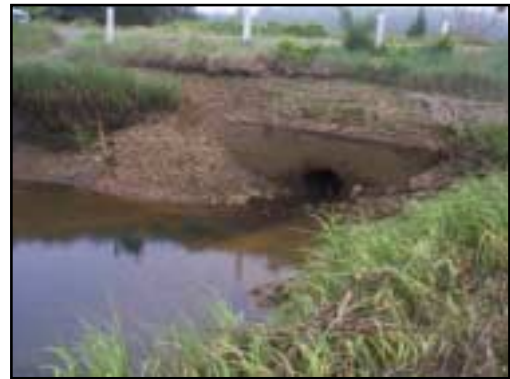
The roadway berm around this seaward headwall and the channel edges are severely eroded. A wide, deep scour pool has formed in front of this 28-inch opening.

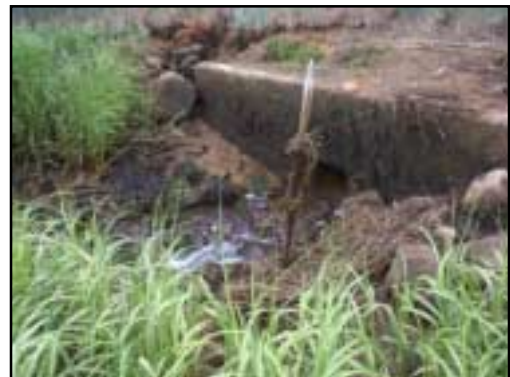
Scouring and erosion scar the upstream side. As was the seaward headwall, this side is consistently submerged. Note the placement of the tide gauge to monitor flow in this system.

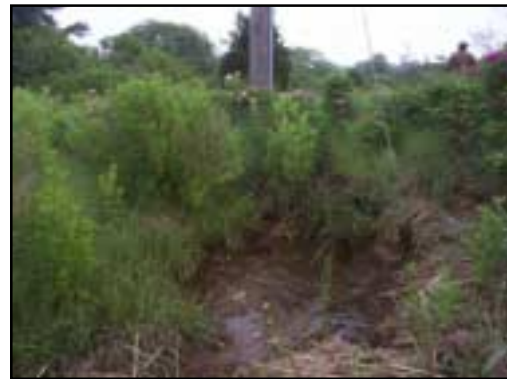
A stagnant pool filled with reeds makes the seaward culvert opening inaccessible even at low tide.

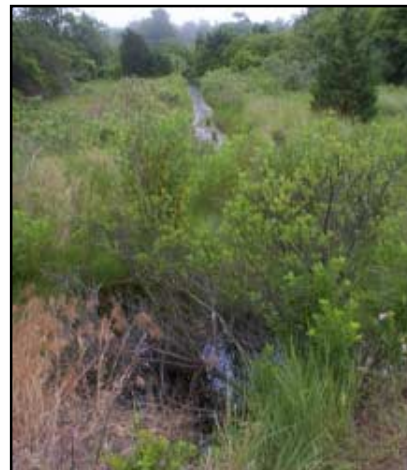
This view into the upstream shrub swamp shows the stagnant channel in the distance.

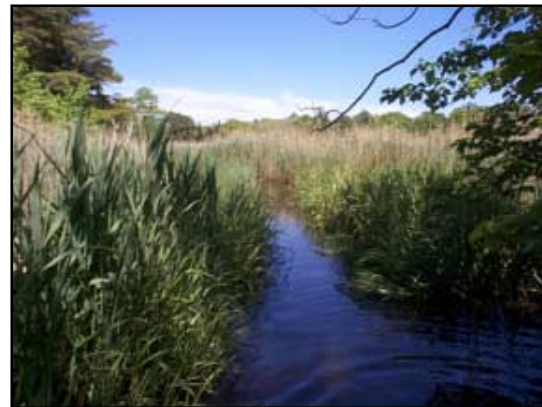
Upstream of Smith Lane the affected area is dominated by *Phragmites*.

Because the restriction caused by site OR-4/EA-3 is severe, the Eastham Department of Natural Resources suggests waiting for the remediation work to be completed and to give the system a chance to adapt to any improvements. Over time, the scope of work that is needed at upstream site EA-4 may become more apparent.

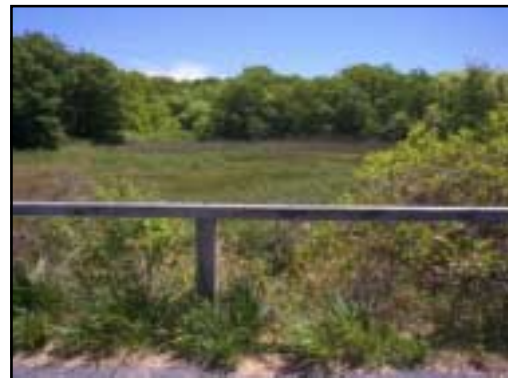
Standing on the bike trail there is a clear view of the upstream affected with its fringe of *Phragmites*.

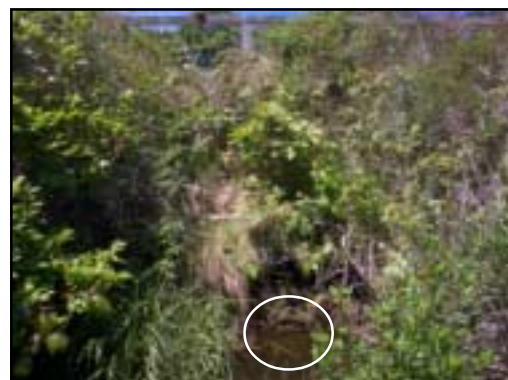
The seaward channel is approximately 2 to 4 feet wide, narrowing to 2 feet upstream of the Rail Trail. Visual indicators of a restriction include significant seaward scouring and minor upstream scouring. Upstream erosion was significant. *Phragmites* growth is minor on the seaward side and fringes the upstream affected area. There did not appear to be significant flow passing through the culvert – stagnant pools of water submerged the pipe opening on both sides of the Rail Trail.

Standing in the upstream affected area one can see how steep the bike trail berm is. The metal pipe is circled in the bottom of this photo.

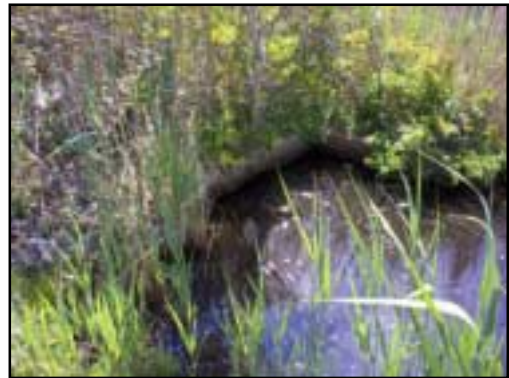
This concrete headwall houses the upstream opening of the 30 inch pipe passing under Route 6. Stagnant water obscures the submerged pipe.

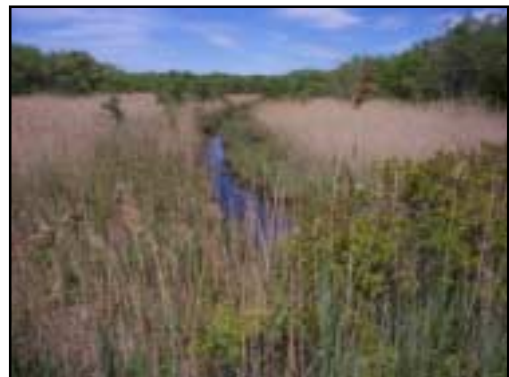
While Phragmites visibly dominates the view into the upstream wetland area from site EA-8, the Wetlands Conservancy Program has identified 1.71 acres of salt marsh further upstream.

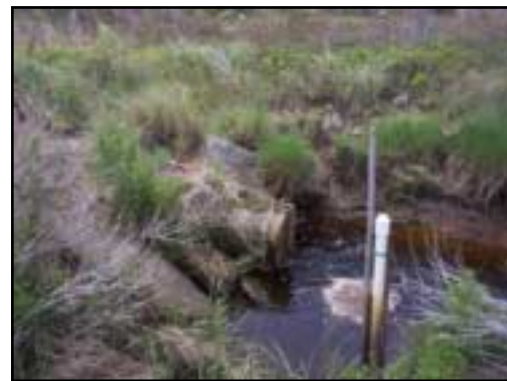
Both the seaward and upstream channels are approximately 5 feet wide. Visual indicators of a restriction include significant scouring and minor bank erosion near the seaward opening. The flapper gate appears to be rusted shut but is missing its bottom 2 inches, which provide a small opening that could allow some salt water to pass upstream. The flapper gate and pipe appear to be consistently submerged at high tide. Visual indicators of a restriction upstream include minor scouring and bank erosion. *Phragmites* growth is dominant in the upstream affected area.

This flapper gate prevents tidal flow from passing upstream via the 2-foot pipe. Note the tide gauge installed at this location.

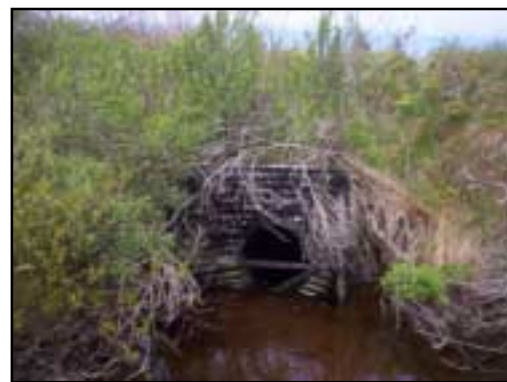
This corrugated metal sluiceway is located on the upstream side of the dike, with its opening approximately 1-foot lower than the seaward side's opening.

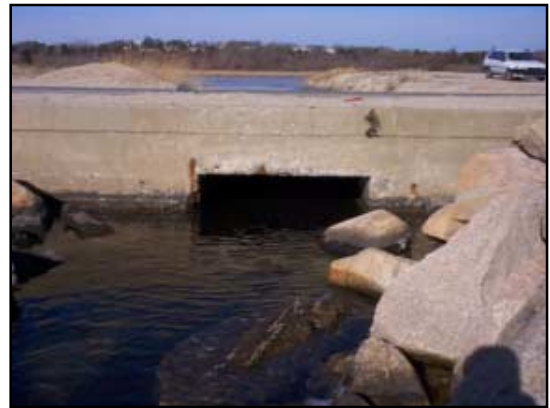
Armored seaward channel flowing through the 6-foot box culvert under Surf Drive into Salt Pond.

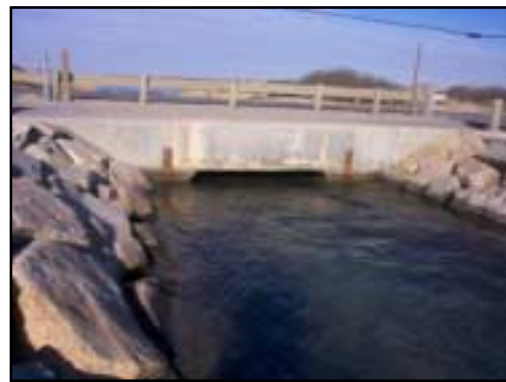
Seaward culvert opening nearly submerged by the rising high tide.

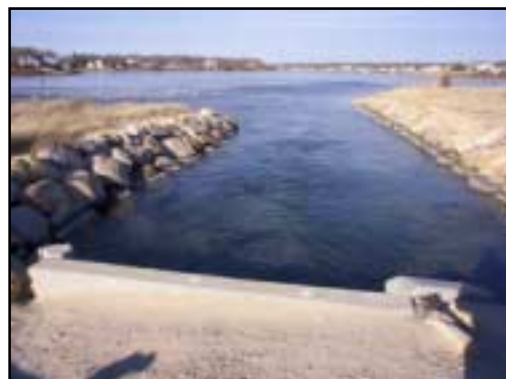
Rock armored upstream channel flowing into Little Pond.

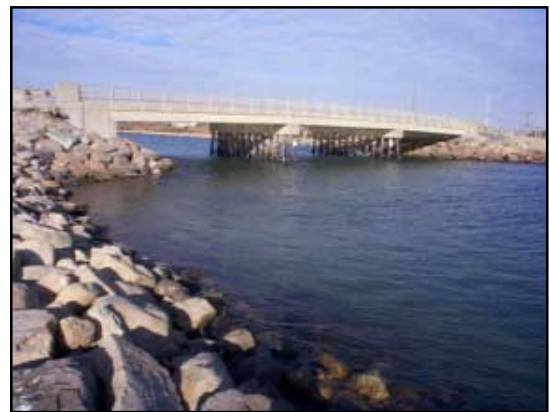
Rock armored seaward channel following the contours of previously scoured channel banks.

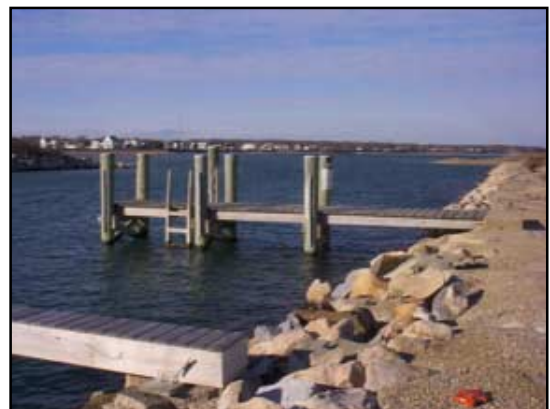
Heavily armored upstream channel flowing into Great Pond.

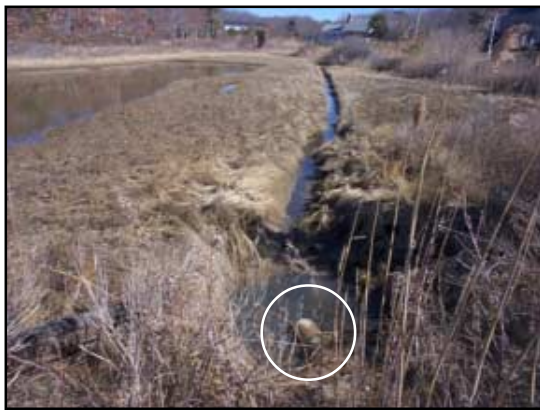
The upstream pipe is nearly submerged in pool of stagnant water, and water ponds in the upstream salt marsh.

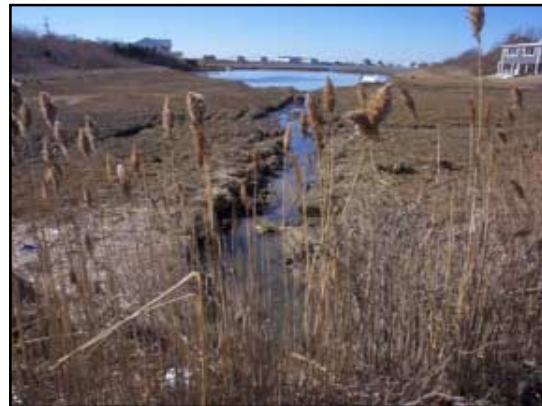
*View of the seaward channel and salt marsh through the *Phragmites* at the culvert's mouth.*

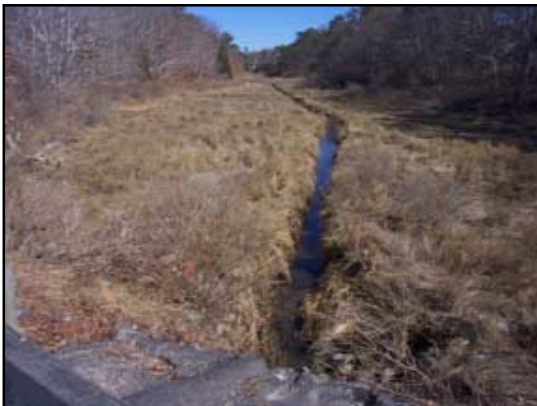
View of upstream affected salt marsh as seen from Teaticket Path.

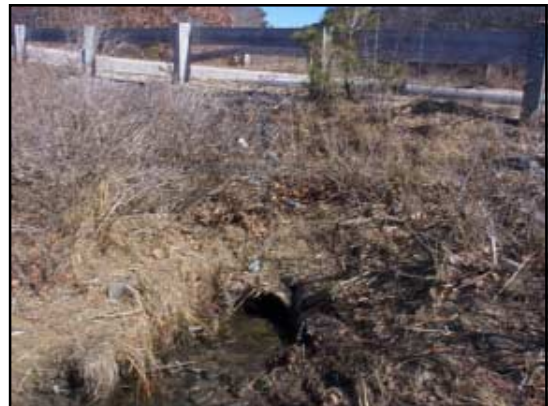
16-inch seaward pipe opening under Teaticket Path.

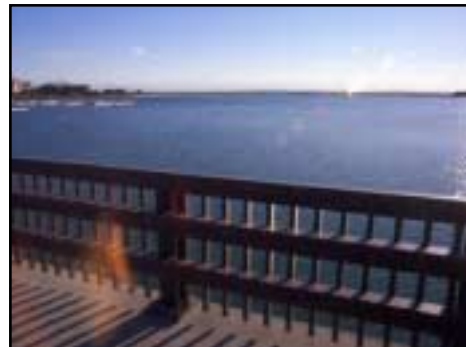
View of Green Pond outlet into Vineyard Sound as seen from Menauhant Road bridge.

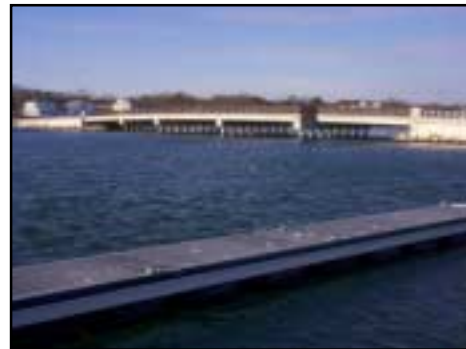
Seaward side of the bridge as seen from the Green Pond Town Landing.

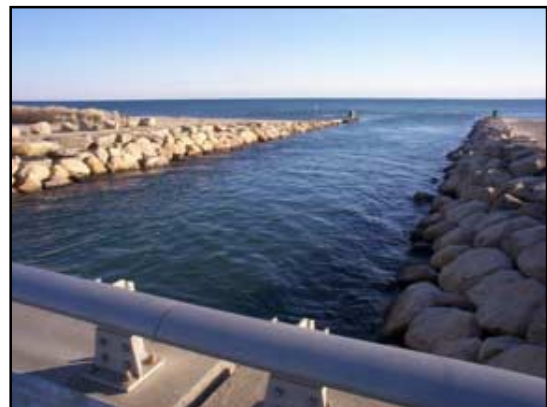
Armored channel on the seaward side of Menauhant Road connecting Bournes Pond with Vineyard Sound.
