Cape Cod Atlas of
**Tidally Restricted
Salt Marshes**

Cape Cod, Massachusetts

Conducted & Prepared by
Cape Cod Commission
for the
Massachusetts
Wetlands Restoration Program

December, 2001

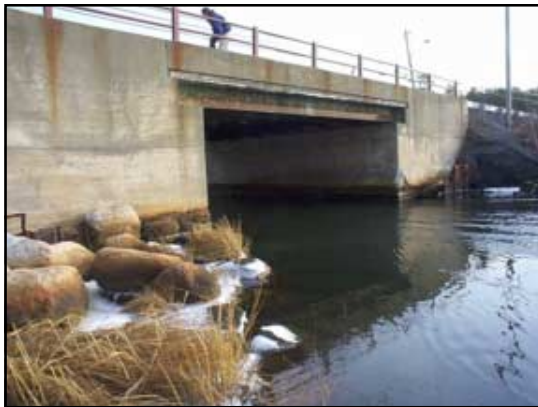
Seaward side of the concrete box opening under Meadow Neck Road.

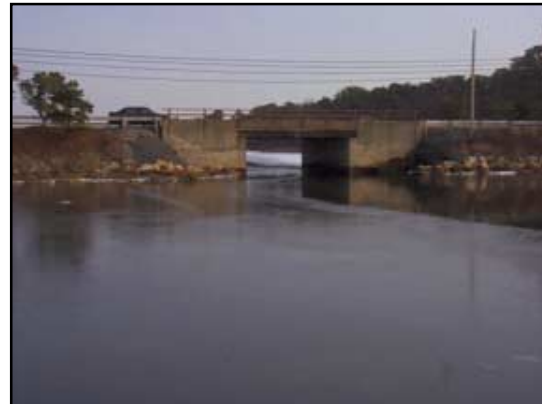
Seaward of the bridge the river channel is approximately 200-400 feet wide narrowing to approximately 100-150 feet wide upstream. Evidence of scour is significant on both sides of the bridge.

View of 27-foot bridge opening, seen to be significantly narrower than the width of the Moonakiss River.

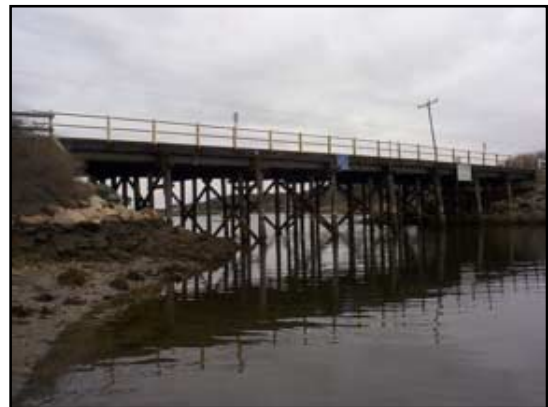
*Lower County Road crosses the Herring River via
this 90-foot bridge.*

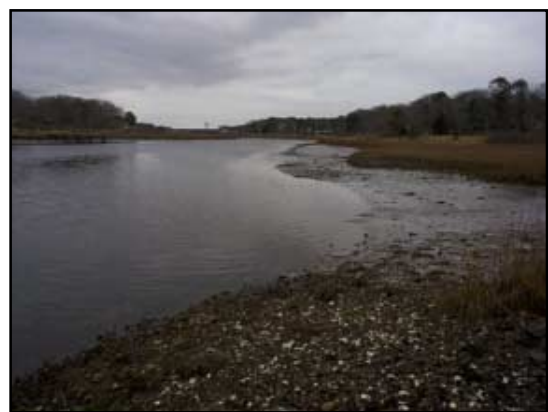
*Seen at low tide, the upstream river bank is lined
with mud and salt marsh, whose edges near to the
bridge exhibit minor vegetation die off.*

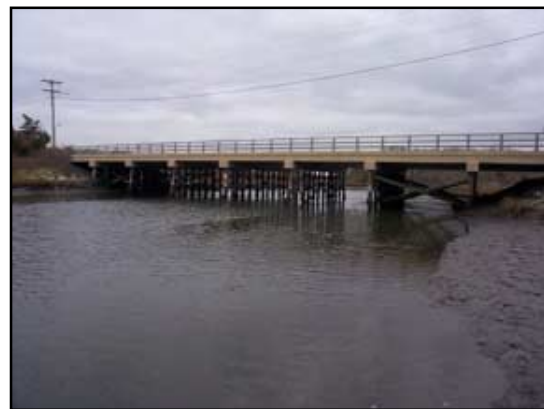
This 155-foot bridge span carries Route 28 across the Herring River.

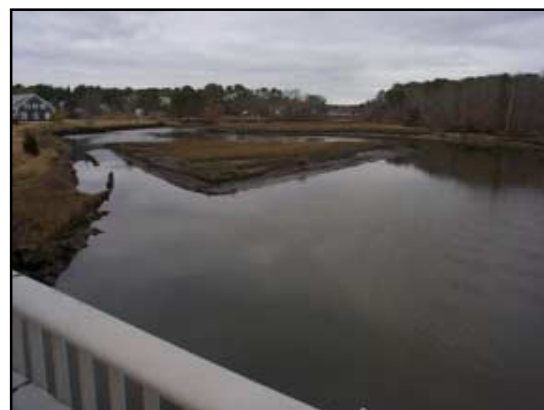
Minor scour, bank erosion, and vegetation die off are visible on the upstream river banks near the bridge.

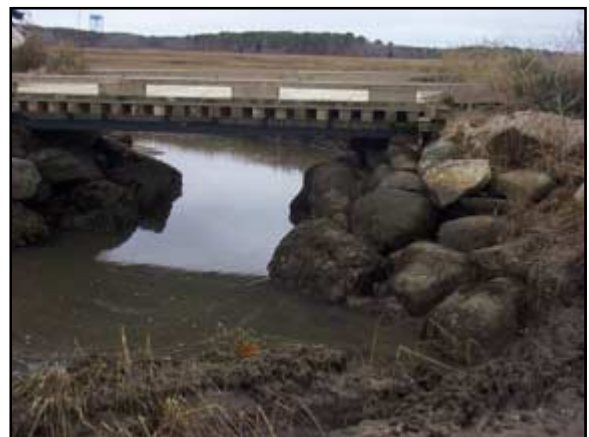
The seaward channel is approximately 15-20 feet wide and is scarred by visual indicators of restriction including major scour, bank erosion, and vegetation die off. The seaward marsh area exhibits low marsh slumping. Upstream of the bridge the channel narrows to 10-15 feet. Visual indicators of a restriction occur there as well including significant scour, bank erosion, and vegetation die off. There was no *Phragmites* observed in the upstream affected area.

Large rocks support this 20-foot bridge, decreasing the area for water to flow and increasing the size of the restriction. Scour, erosion, and vegetation die off are all evident in this channel.

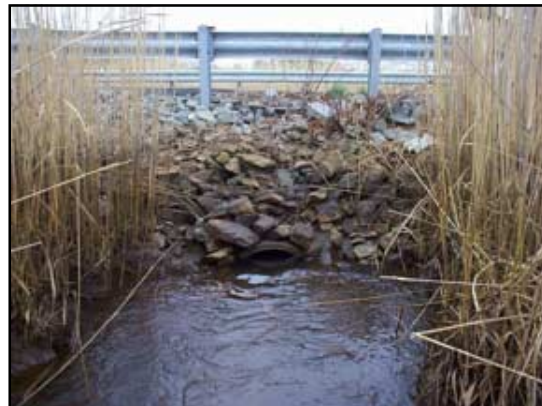
The top of the 20-inch pipe is barely visible here; although *Phragmites* lines the seaward channel near the roadway berm, salt marsh dominates the seaward area.

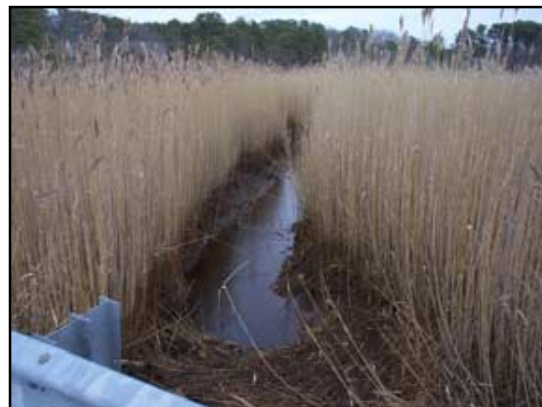
Phragmites dominates the upstream marsh area and old reeds block the pipe opening just below the Lothrop Road guard rail.

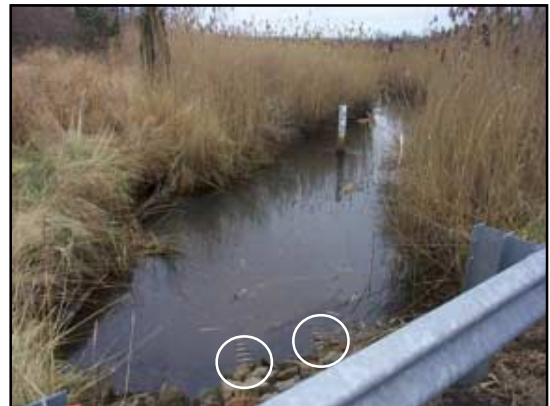
Two pipes are barely visible through the stagnant, murky waters by Kildee Road; *Phragmites* lines the seaward channel.

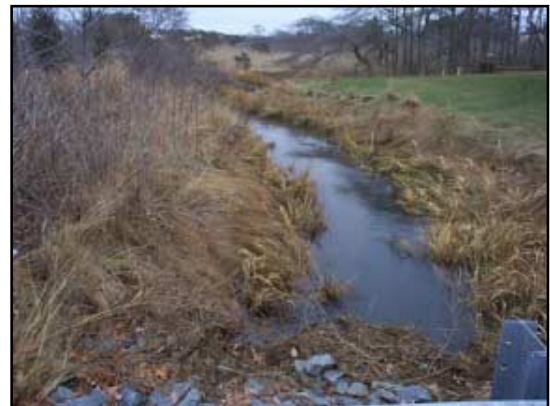
Lawn and shrubs line the upstream channel near the restriction, but *Phragmites*, seen in the distance, is the significant vegetation type in this upstream affected area.

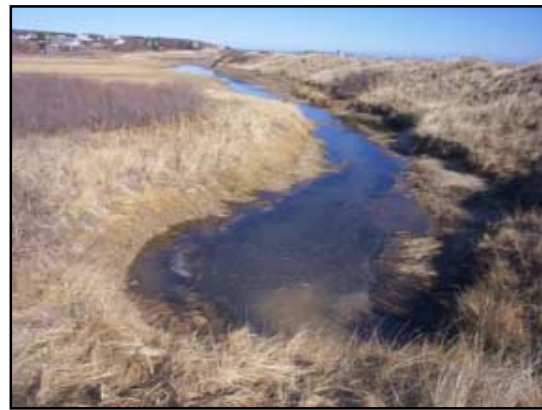
Even through the clear water the seaward pipe opening is not visible, however scouring is visible on the sides and bottom of the channel.

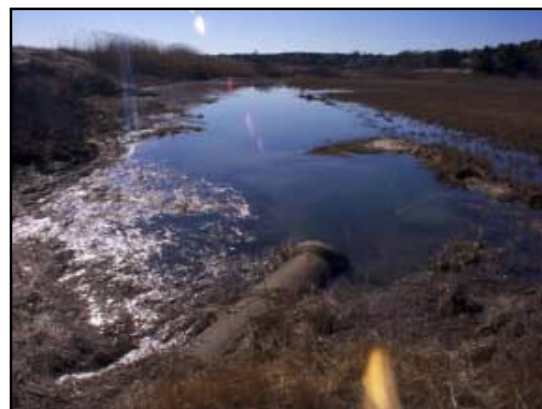
The concrete pipe juts out into the upstream channel, uncovered for approximately 10 feet, increasing the length of the restriction beyond that of just the roadway berm. When visited during high tide, the difference in water levels between the seaward and upstream area was dramatically different and made it hard to approximate channel width. Most of the tidal flow in this channels' system was trapped upstream of site HA-6 but seaward of HA-7 (see site HA-7 for an illustration).

View of the upstream salt marsh at high tide with the 2.5 foot concrete pipe nearly submerged in the channel.

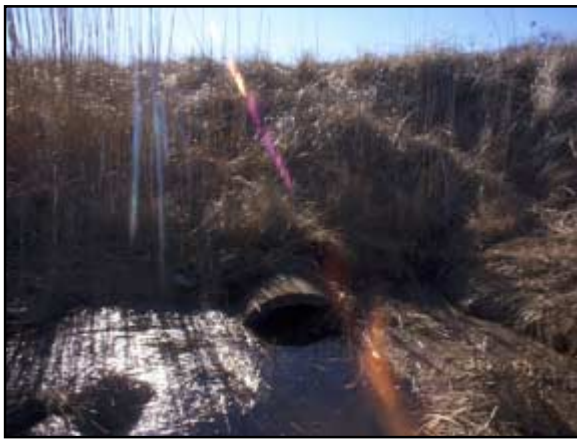
The 20-inch seaward side opening of the concrete pipe is almost submerged at high tide.

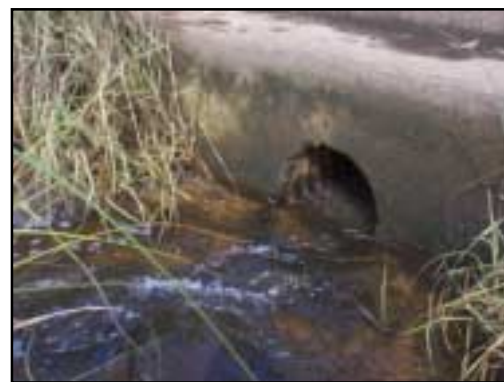
This 16-inch corrugated metal pipe set in the concrete headwall passes the flow of the Red River under Deep Hole Road.

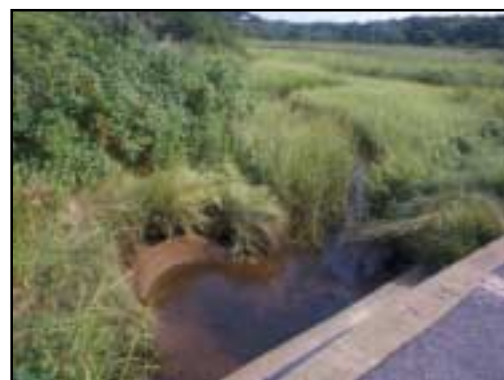
Visual indicators in this upstream affected marsh include a small scour pool near the pipe opening and significant growth of *Phragmites* and cattails.

According to the Director of the Chatham Water Quality Laboratory, the area upstream of Deep Hole Road is a natural low point that collects significant fresh water drainage and is therefore a transition zone. An increase in the size of the pipe would likely not change the area affected by tidal flow, but could serve to make the existing salt marsh healthier.

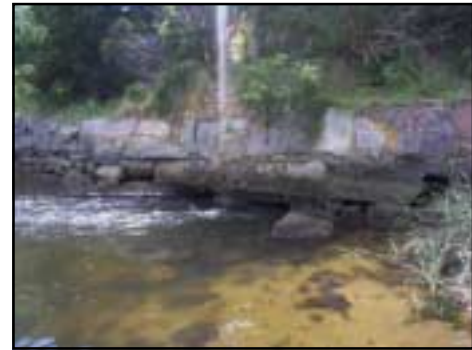
These 2 box culverts pass the flow of the Muddy River under Route 28. The stone slab retaining wall supporting the culverts appears to be in poor condition.

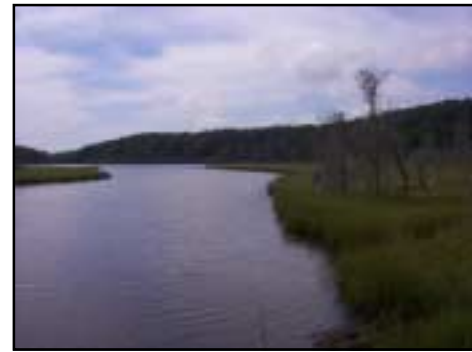
Upstream of Route 28 salt marsh exists along the banks of the Muddy River.

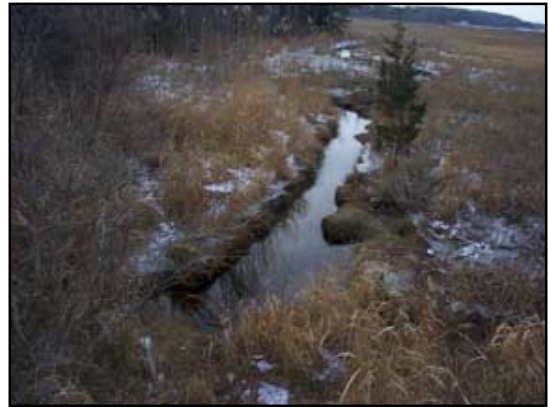
Phragmites and shrubs are taking hold in the salt marsh near the seaward opening of the pipe.

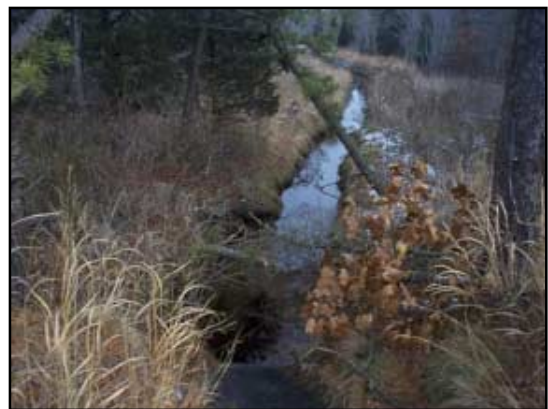
View into the 0.73 acres of shrub swamp located upstream of site MA-1.

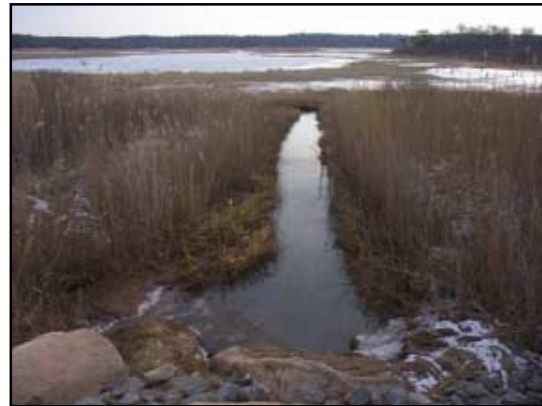
Phragmites grows in the marsh east of the road near this 4-foot channel connecting to the Great River.

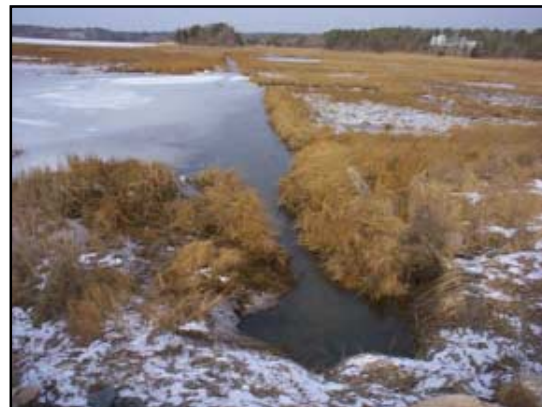
Visual indicators of a restriction seen near the western end of the pipe include this small scour pool and pooling/ponding water.

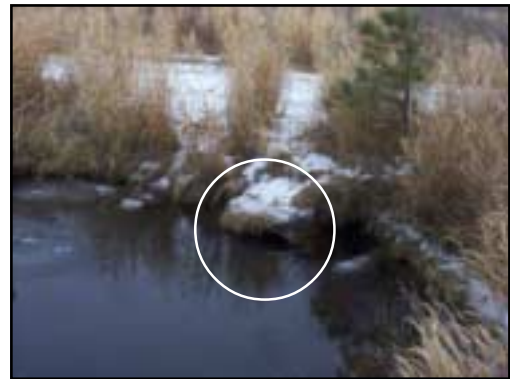
Seen during mid, incoming tide water flows over the channel banks and pools at the roadway berm; the top of the pipe is barely visible under a clump of grass (opening circled in photo above).

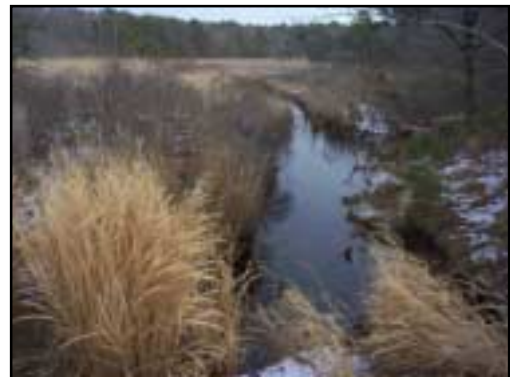
Upstream of the Great Hay Road restriction the land is part of the Mashpee National Wildlife Refuge. *Phragmites* growth is extensive toward the rear of this affected area.

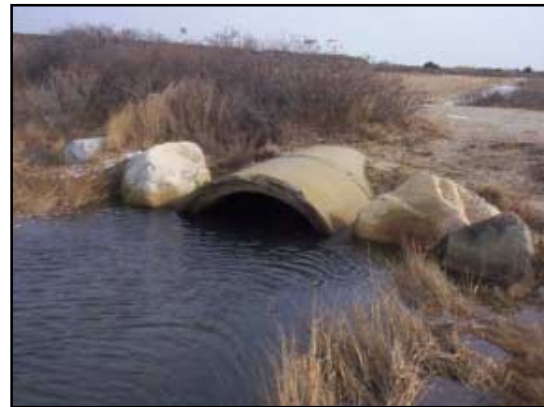
The seaward opening is seen nearly submerged during this mid, incoming tide. Large boulders have been placed by the culvert to help prevent erosion of the dirt berm.

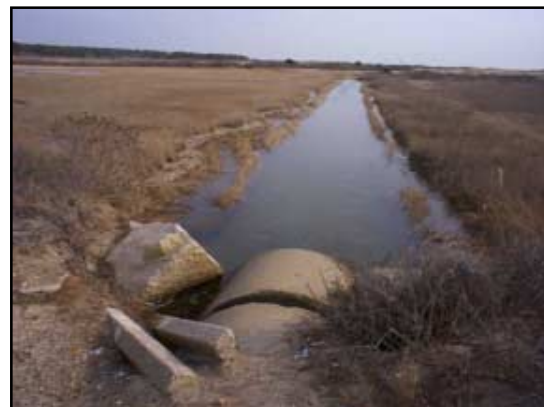
While this restriction is not egregious, the channel width-to-culvert opening ratio does not allow free flow and does not resemble natural stream conditions. While the pipe is broken in such a way that the severed segments remain in place, there is cause for future concern. Should these segments shift or roll from their *in situ* break they could contribute further to the restriction. The Massachusetts Wetlands Restoration Program is currently studying this site for potential future restoration.

Looking into the upstream channel scour pools are visible, as is the clean break in the exposed pipe.

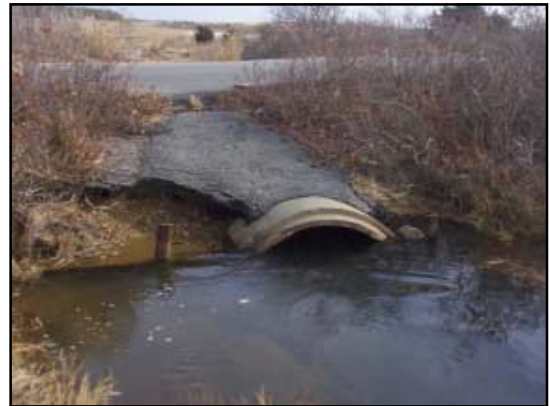
Pavement extends out over this seaward pipe directing roadway runoff into the tidal channel and likely adding to the erosion seen occurring around this pipe.

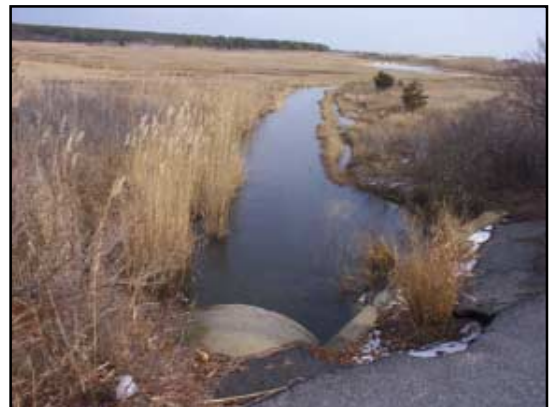
Phragmites and shrubs are seen encroaching into the marsh near the upstream pipe opening.

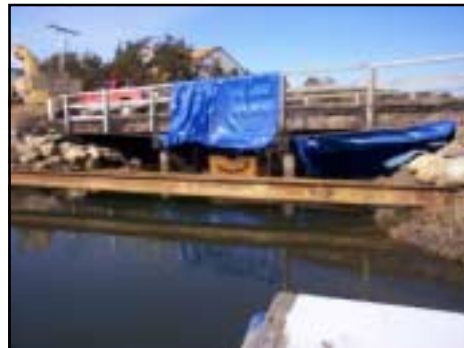
Reconstruction of the bridge began in the fall of 2000. The project is intended to widen the bridge and increase its height above the Santuit River. Unfortunately, reconstruction did not include increasing the width of the span to allow increased tidal flow.

Construction underway on the Santuit River bridge to widen and raise the roadway; unfortunately plans do not include alleviating the restriction.

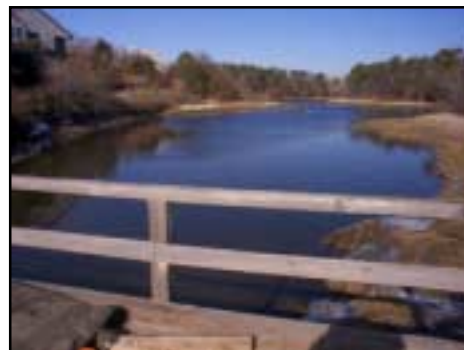
Upstream of the bridge salt marsh lines the eastern riverbank while development is visible on the western bank.

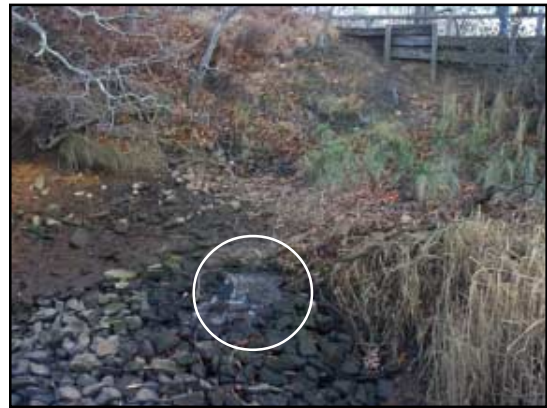
An eroding retaining wall helps support the Cape Cod Rail Trail that is restricting tidal flow in Namskaket Creek – water is seen bubbling out from under a pile of rocks that covers the 1-foot pipe.

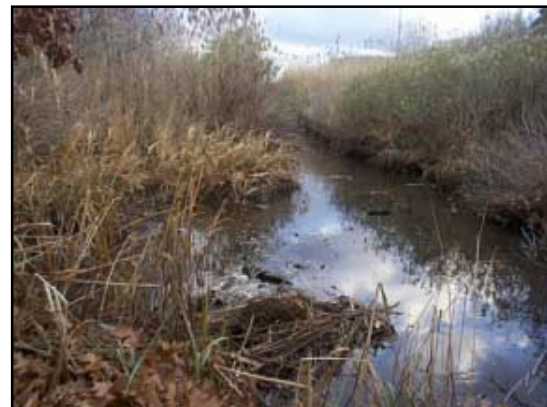
Phragmites and shrubs are seen taking over the once salt marsh upstream of the Rail Trail.

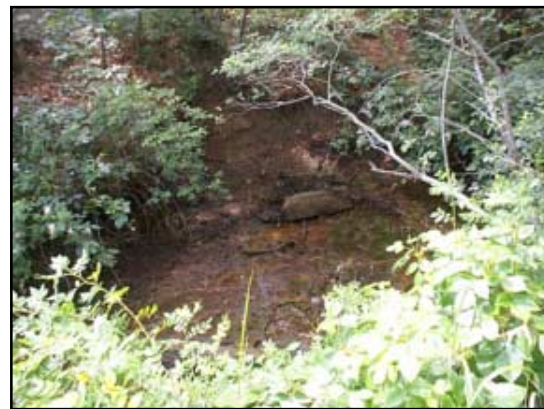
The width of the seaward creek channel is approximately 5 feet, while the upstream creek is approximately 1 to 3 feet wide. The entire site is in serious disrepair. The seaward pipe opening was barely visible and covered by a stone block as well as other debris and mud. Upstream of the bike path the 1-foot opening is visible submerged in a stagnant pool and clogged by dead *Phragmites* reeds and muck. Visual indicators of a restriction are numerous including major seaward scouring and erosion and significant upstream scouring and erosion. *Phragmites* dominates both the seaward and upstream vegetation. This restriction has persisted for so long that the upstream affected area has become mainly a fresh-water marsh.

The berm of the bike trail is a severely eroded, slick mud bank. This stone slab marks the pipe's opening.

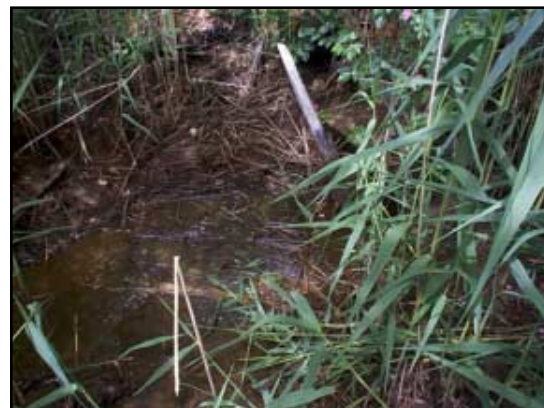
Reeds and high stagnant water block the upstream opening from view.

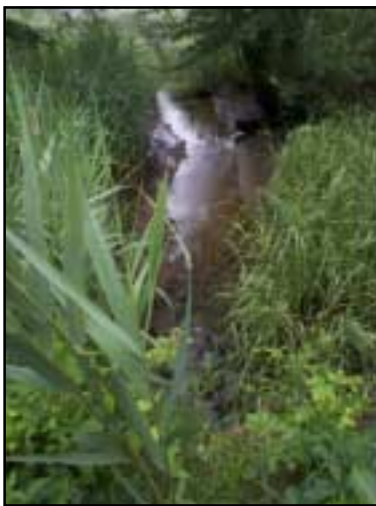
Phragmites and shrubs are visible in the upstream area as seen from the upstream side of the pipe.

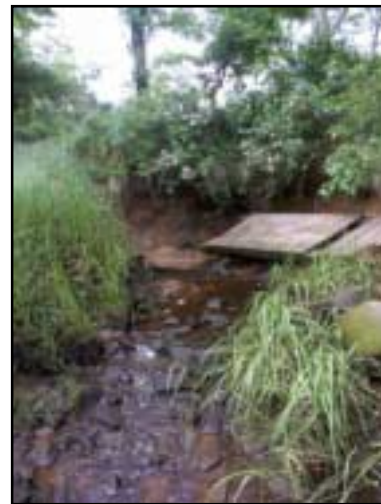
The seaward creek channel is approximately 5 feet wide, narrowing upstream to approximately 2 to 5 feet wide. Visual indicators of a restriction include major scouring and erosion on the seaward side and minor scour and erosion upstream. *Phragmites* growth is significant both seaward and upstream of this restricted site.

Erosion scars the area near the pipe opening, which is blocked by this piece of dock and other debris.

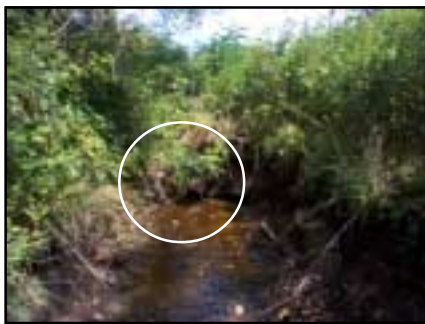
This channel runs between sites OR-5 and OR-6, ending abruptly at the dirt berm where the 8-inch clay pipe is seen poking out at the bottom.

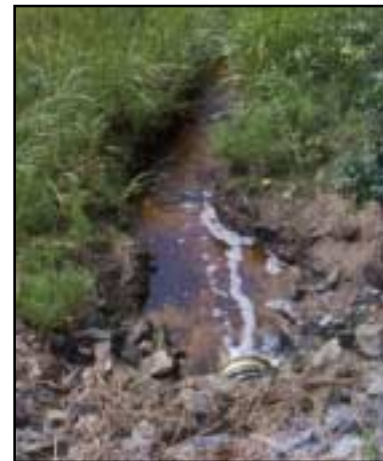
View of the seaward opening of site OR-5 – scour and erosion are present at this 12-inch opening.

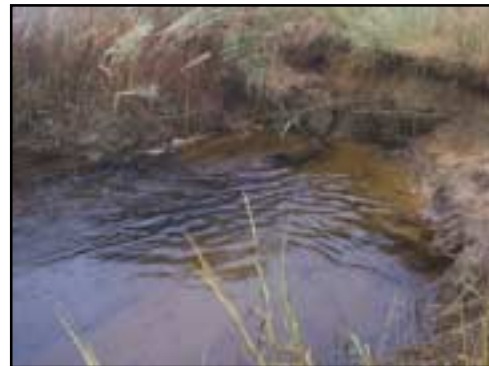
The seaward side of the berm is subject to severe scouring and erosion. The submerged 1-foot clay pipe is seen here during an outgoing, low tide cycle.

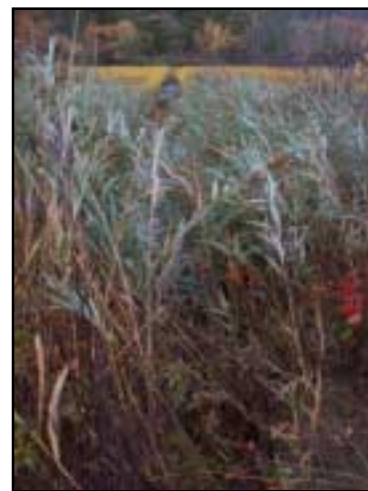
A significant amount of *Phragmites* growth is observed here upstream of the old cranberry bog berm. Salt marsh is visible in the distance.

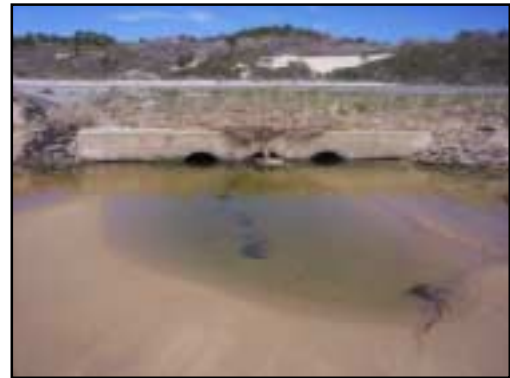
A large scour pool is visible in front of these three 30-inch culverts. Water marks and debris left by high water are visible on top of this headwall.

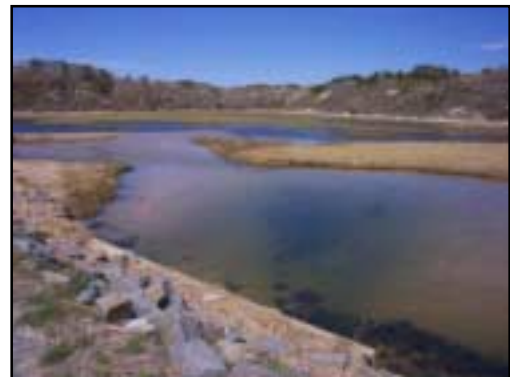
Visible in the foreground is a corner of the large, upstream scour pool along with the algae-covered salt pond in the rear. Coastal bank is clearly containing this upstream affected area.

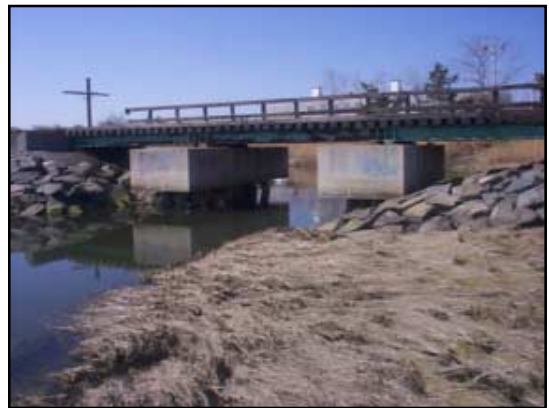
Water is detained upstream of the bridge due to an approximate 3-foot rise from the seaward to upstream creek-bed elevation caused by rocks built up under the bridge. The stream is approximately 30 feet wide on the seaward side narrowing to 20 feet wide upstream of the bridge. Visual indicators of a restriction include a significant scouring basin and significant bank erosion on the upstream side, as well as minor scour and erosion seaward of the bridge. *Phragmites* is not present in the seaward marsh area however, it fringes salt marsh upstream of the bridge.

This 22-foot bridge span enables the Penn Central Railroad to cross Mill Creek.

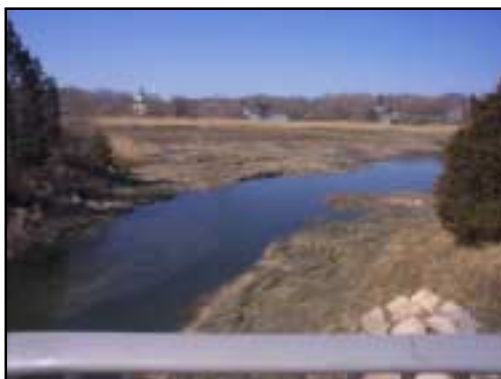
Phragmites thickly fringes the salt marsh upstream of the Route 6A bridge over Mill Creek.

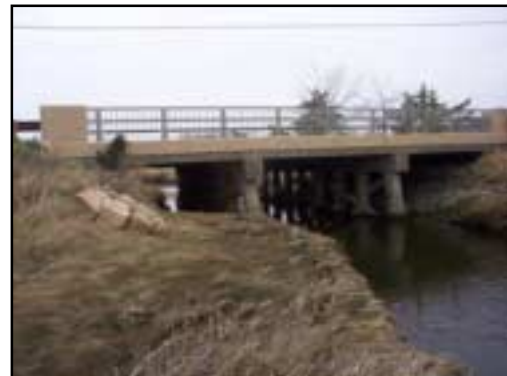
View of Mill Creek flowing under the Route 6A bridge at high tide.

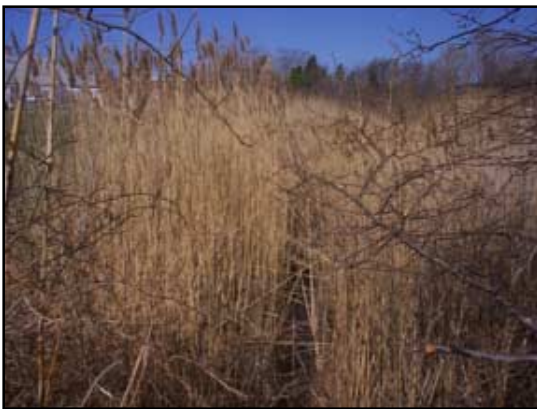
Phragmites dominates the upstream affected area just across the street from extensive salt marshes.

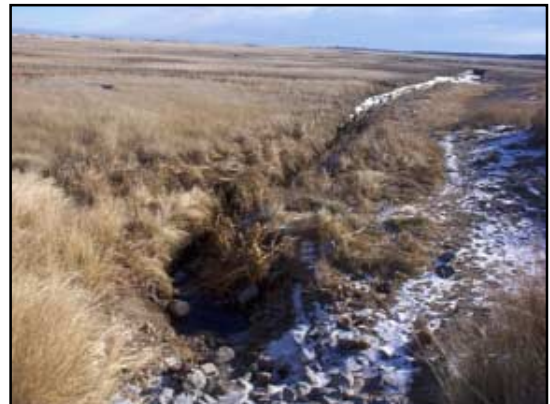
The seaward channel varies from 2-to-4 feet wide with minor scouring and erosion scaring its banks near the pipe opening. The upstream channel is approximately the same width as the culvert. Healthy, extensive salt marsh exists just to the seaward edge of the road while *Phragmites* dominates upstream.

Salt marsh dominates the view from Boardwalk Road; a scour pool and erosion are visible in the foreground where this channel tries to pass through the 20-inch pipe.

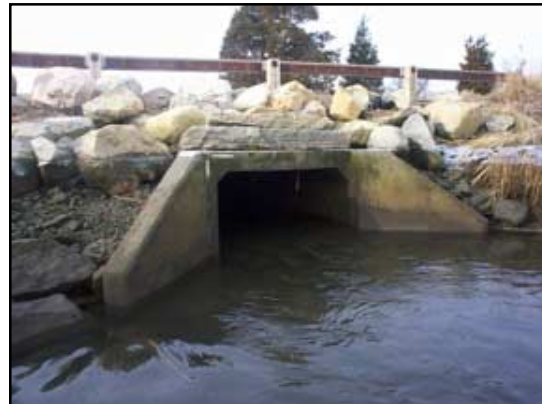
This 6-foot box culvert passes the flow of Dock Creek under Dewey Avenue.

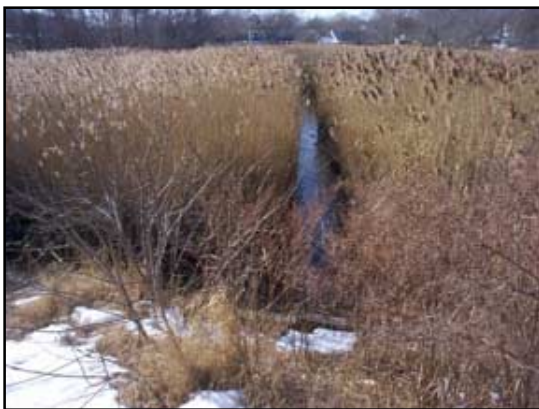
Phragmites dominates the upstream affected area of site SA-5.

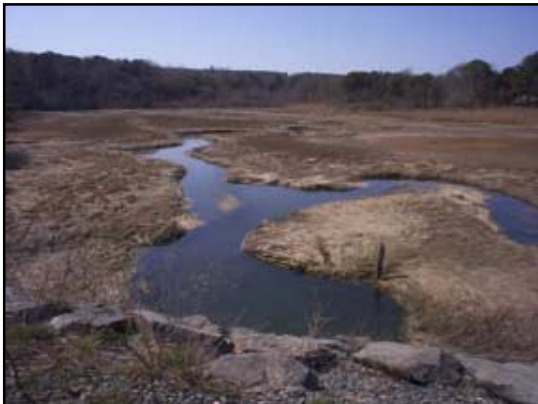
The upstream salt marsh is still flooded during this mid tide cycle. Phragmites is visible fringing the back extent of the affected area.

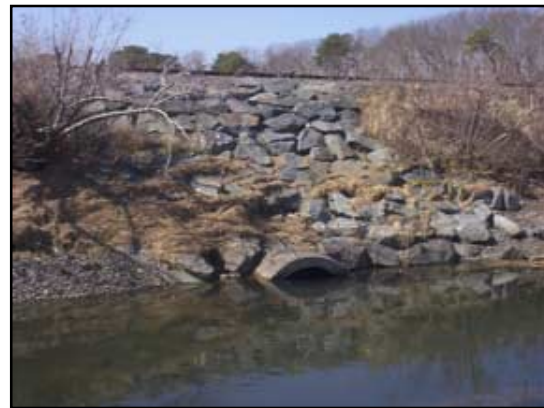
The creek is approximately 7 to 10 feet wide seaward, narrowing to approximately 5 feet upstream of the railroad bed. Visual indicators of a restriction include a major scouring basin and erosion scarring the channel near the seaward opening. Additionally, minor scouring is visible near the upstream opening. *Phragmites* fringes the upstream affected salt marsh.

The 3-foot pipe is nearly submerged on this mid tide and is dwarfed by the pool of water detained by the railroad bed and this undersized culvert.

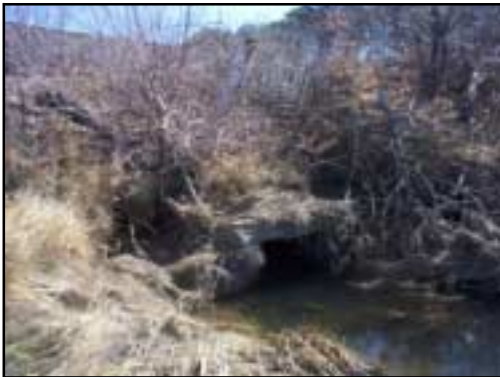
View of the upstream end of the box culvert through which the flow of Pine Island Creek must pass.

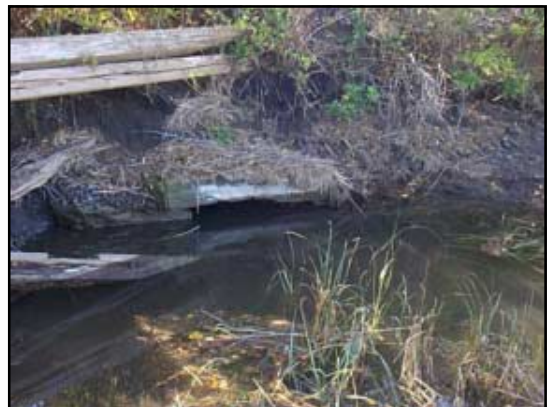
The creek channel is approximately 3 feet wide on the seaward side, widening to 5 feet upstream of the railroad (typically, channels narrow upstream of a restriction). While the culvert itself is structurally intact, the conditions of the channel and banks around it are poor. Significant scouring has formed a large pool near the seaward opening and constant scouring is eroding the railroad bed above and around both stone culvert openings. Scour and erosion scar the upstream channel. *Phragmites* does not have a major presence in the upstream affected area but is present on its fringes.

The top stone of the box culvert is just visible above the water and erosion is seen behind it eating away at the railroad bed.

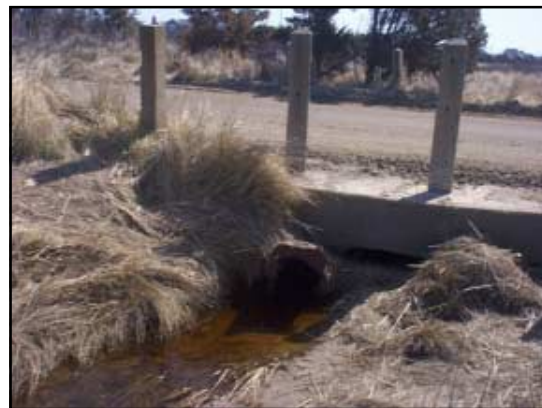
Old Harbor Creek flows parallel to Salt Marsh Road and Springhill Beach, crossing under Foster Road just south of the Forest/Salt Marsh Road intersection. Old Harbor Creek flows under Foster Road (a private dirt road) via a 16-inch diameter corrugated metal pipe. The pipe is in poor condition – it is clogged by sand, crushed, and misshapen – and erosion is undercutting the low berm in which it is set.

This 16 inch pipe passes the flow of Oak Harbor Creek under Foster Road.

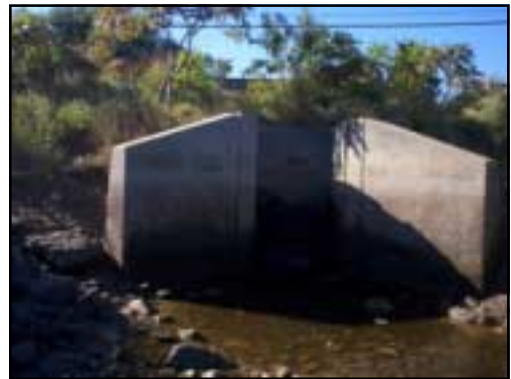
Tidal flow is totally restricted under Ploughed Neck Road by a tide gate, effectively shutting off the culvert. The tide gate covers a 3-foot diameter concrete culvert that is set low in an 8-foot high concrete headwall with wings. The upstream opening is fitted with a frame to support the placement of water-tight stoplogs. The structures appear to be in good condition. There is an elevation difference of approximately 4 feet between the seaward and upstream pipe openings.

This 8-foot high concrete wall houses the 3-foot pipe covered with a closed tide gate (hidden in the shadows of this picture). However, high water marks are visible well above it.

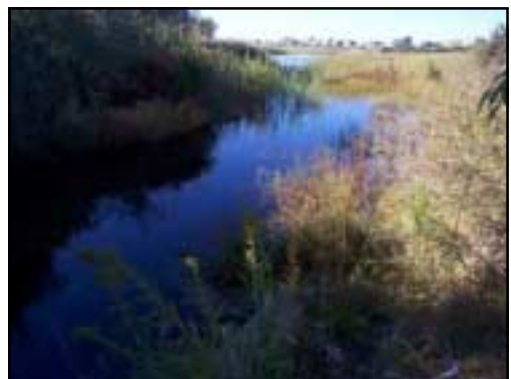
Upstream the Cow River extends for a short distance from the roadway, then opens into the pond beyond. Because of the tide gate, this affected area is not receiving any tidal flow.

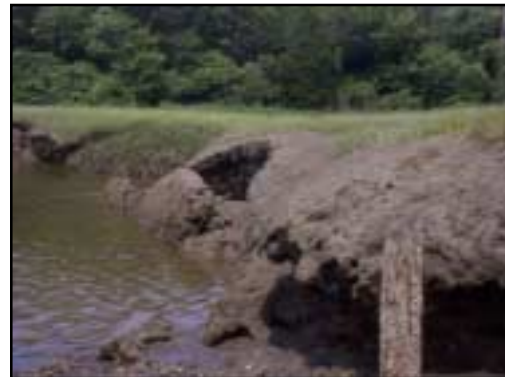
Seen close up, this erosion, slumping, and vegetation die-off are scarring the banks seaward of the Scorton Creek bridge.

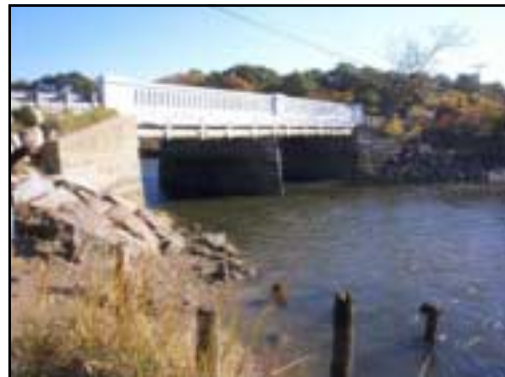
This 60-foot long stone bridge moves Route 6A traffic over Scorton Creek.

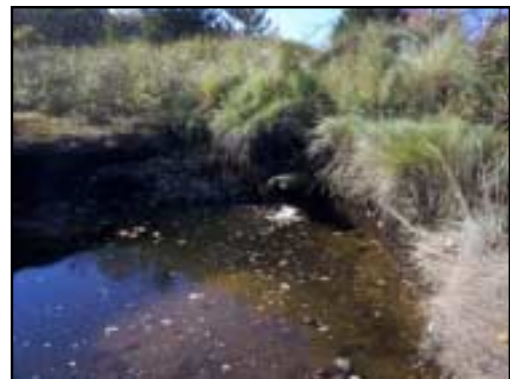
Two channels, 4 and 6 feet wide, converge at the seaward side of the pipe. Two channels, 2 and 3 feet wide, work their way off into the upstream affected area. The seaward opening is inverted — set high in the roadway berm, making it impossible for lower tidal waters to pass through the pipe. A deep scour pool has formed at the seaward opening and erosion is deteriorating the channel banks. Upstream, both scour and erosion scar the site. *Phragmites* growth is significant in the upstream affected area.

A large, deep scour pool marks the opening for the 18-inch pipe that passes flow under the unpaved extension of Pine Terrace. The pipe is sited high in the berm and cannot pass the full tidal range.

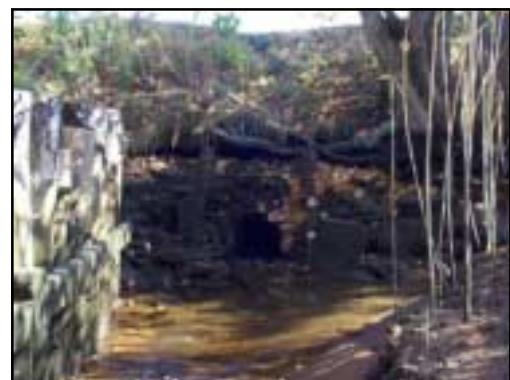
Phragmites, visible in the foreground, is the only thing growing in the exposed mud near this upstream pipe opening.

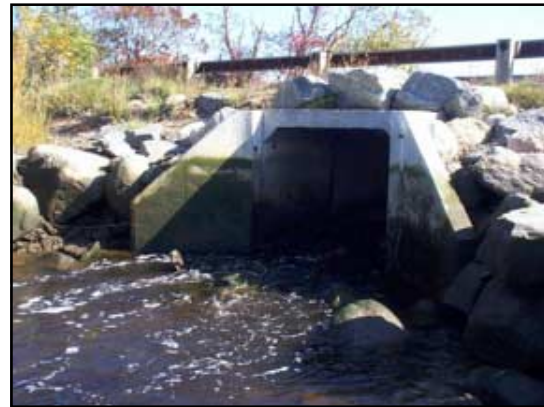
This 6 by 6-foot concrete box culvert passes the flow of Scorton Creek (Sandwich) under Jones Lane.

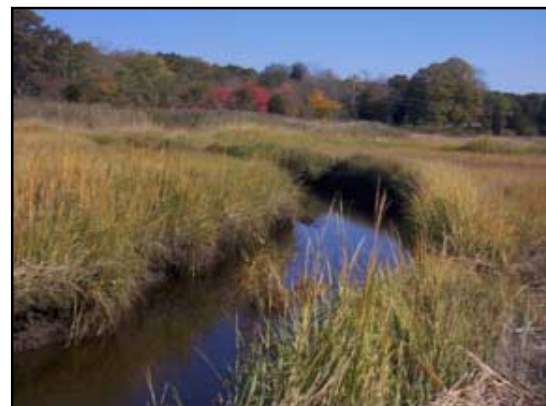
View of the upstream affected salt marsh; *Phragmites* is visible fringing the marsh area.

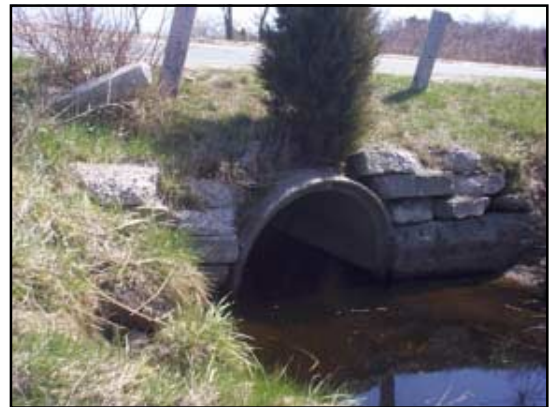
This 4-foot concrete pipe passes the flow of Scorton Creek (Barnstable) under Route 6A.

According to the Sandwich Conservation Officer, at the time of this writing this culvert is under consideration for remediation but requires outside funding due to the fact that the structure is within a Massachusetts Highway Department road layout. The town is currently conducting a flushing study of the entire Scorton Creek system, with funding provided by a Cape Cod Commission technical assistance grant.

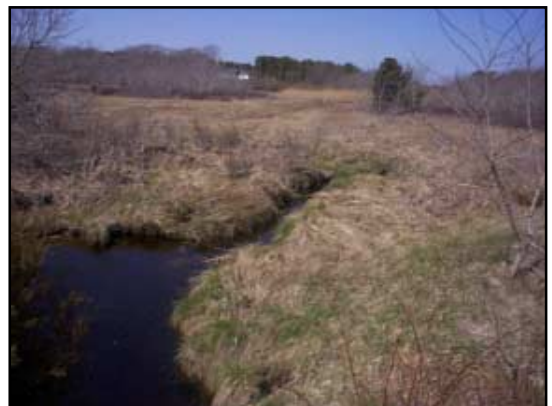
The upstream affected seen here is scattered with cattails, shrubs, trees, and *Phragmites*.

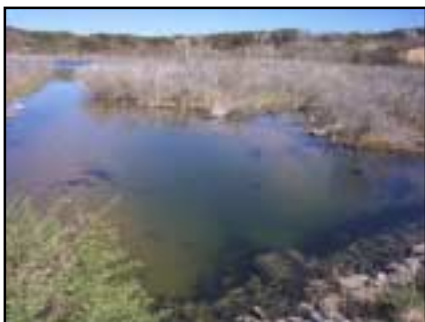
Dead shrubs comprise much of the vegetation currently observed in the upstream affected area – a symbol of the reintroduction of tidal flow and associated slow changes in vegetation.

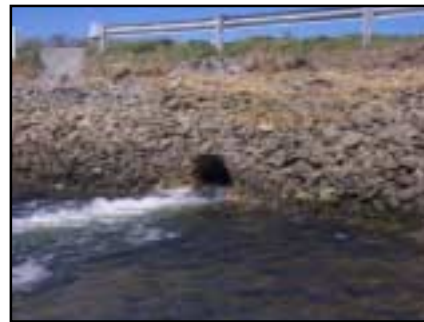
This 3-foot culvert passes tidal flow under Mill Pond Road, here water is seen rushing seaward on an outgoing tide.

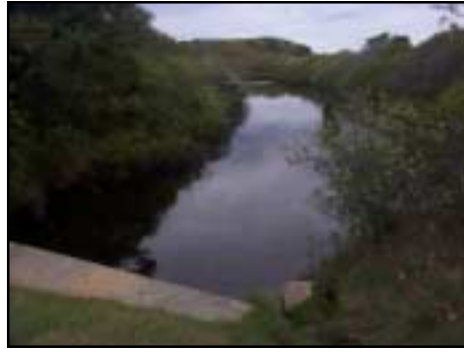
Once upstream of both restrictions the banks of the Pamet River take on a freshwater, riverine appearance.

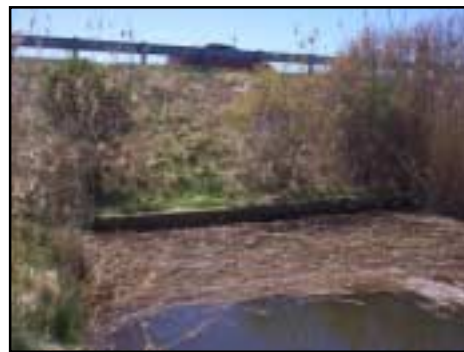
Set far below the roadway of Route 6, this concrete headwall marks the upstream opening of the pipe conveying flow from Cape Cod Bay all the way under Routes 6A and 6 – crossing length estimated at one-eighth of a mile. The pipes' opening is submerged beneath stagnant water and obscured by dead reeds.

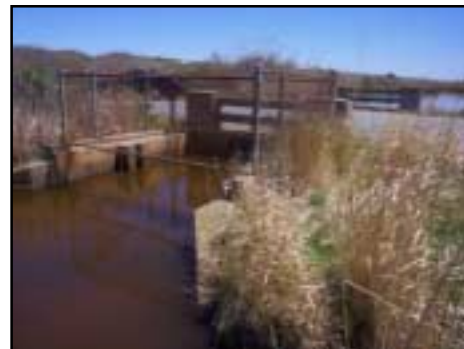
A weir controlling the flow under High Head Road is protected from possible vandalism by this chain link fence.

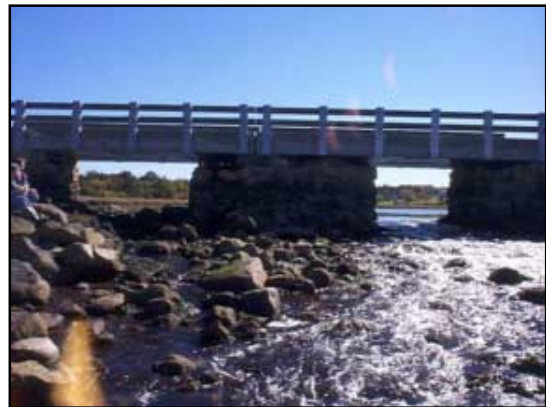
Water is detained upstream in Halletts Mill Pond due to rocks built up in the streambed underneath the Keveney/Mill Lane Bridge.

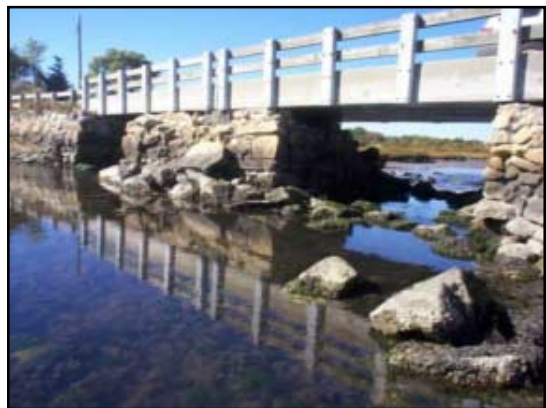
At low tide water flows downhill out of Halletts Mill Pond and seaward via Mill Creek into Cape Cod Bay.

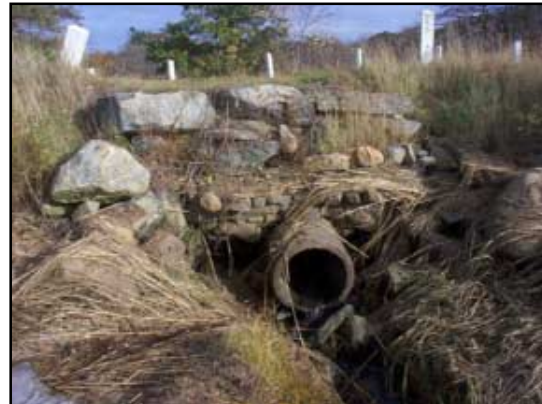
This concrete pipe runs under Mill Lane — it is set high above the streambed and scouring and erosion are undermining the headwall.

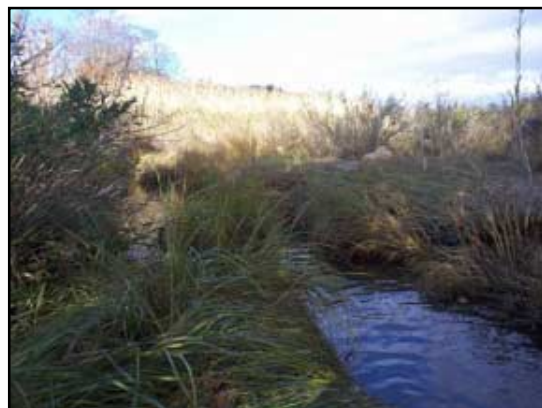
Phragmites and shrubs are seen invading the upstream affected area of site YA-2.

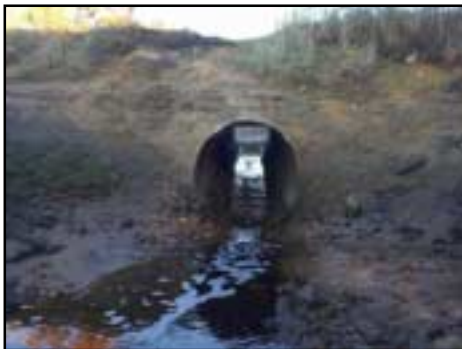
Severe erosion is washing away the berm around the pipe, which is not clogged allowing this clear view upstream.

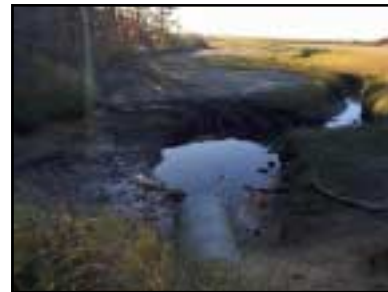
Vegetation die off and erosion, evident at this site, are caused by scour and pooling as Bass Creek attempts to pass through this 4-foot pipe.

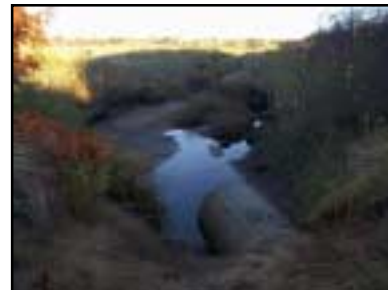
Scour and erosion are degrading the upstream channel while reduced tidal flow has caused a significant change in this upstream salt marsh vegetation.

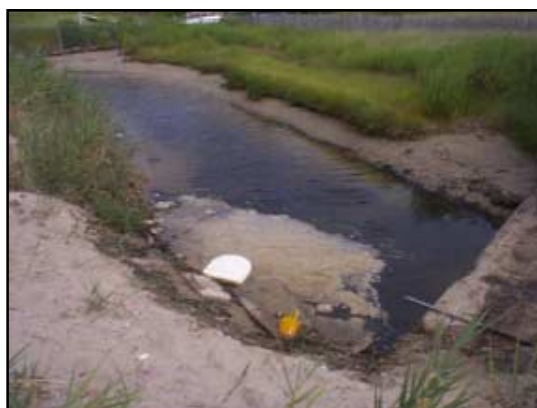
The seaward channel winds from Lewis Bay and across Bay View Beach to end abruptly at this concrete headwall. Trash and silt collect near the opening.

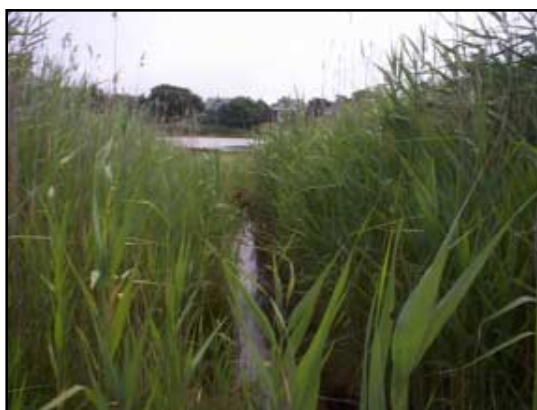
Phragmites lines the upstream channel that flows into the salt pond, seen here in the distance.

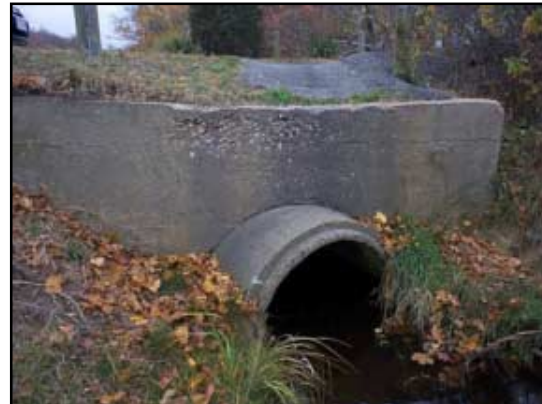
Roadway runoff is directed to the channel at the seaward opening of the pipe under Park Avenue.

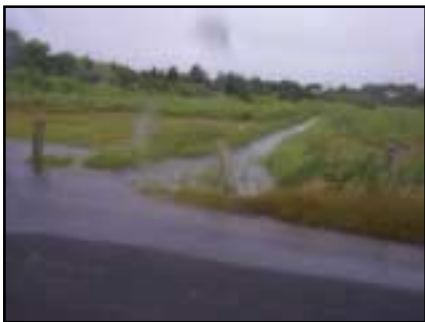
The upstream opening of this culvert is clogged by the crumbling roadway and culvert structure causing Shore Road to flood under normal conditions.

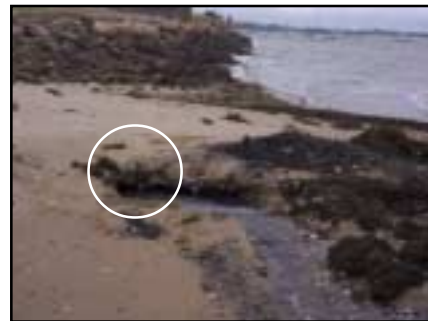
This hole was just dug in the sand to expose the 1-foot seaward opening of the pipe.

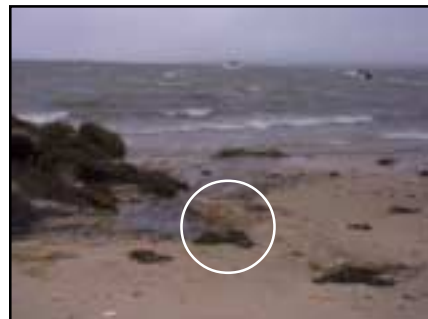
The hole in the sand marks the pipe's outlet, seen here at low tide, showing its relationship to Lewis Bay – obviously the pipe is regularly submerged at high tide.

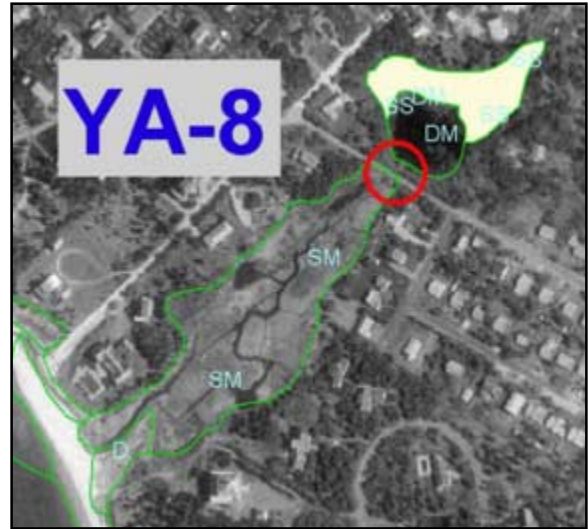
Upstream Affected Area (acres): SS – 1.06.

Phragmites visibly dominates the upstream affected area.

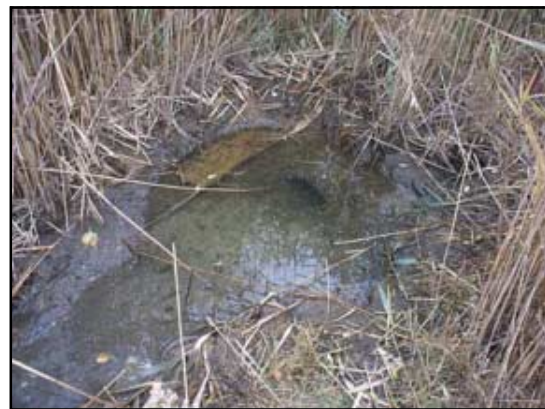
The seaward opening of the pipe (visible here) is submerged and partially blocked by silt; Phragmites invades the area around its opening.

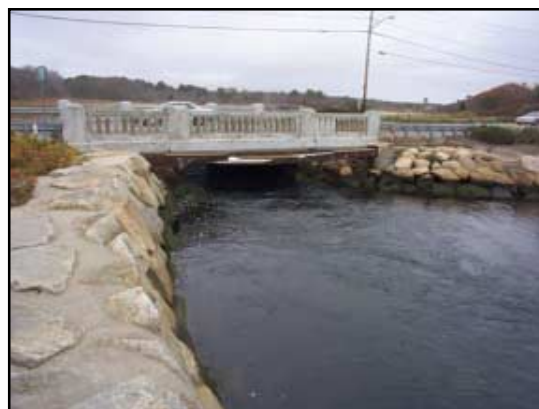
Water moves swiftly on the outgoing tide as the river squeezes itself through the undersized bridge span.

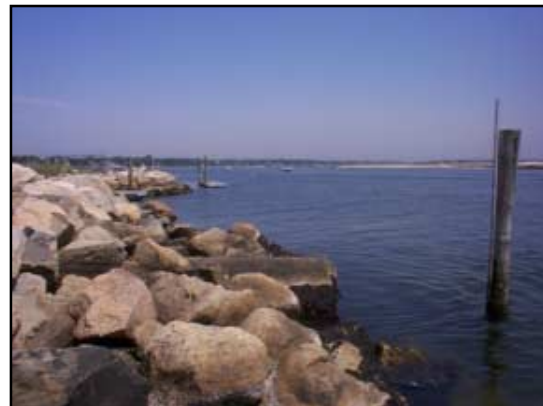
This 4-foot pipe conveys flow for 830 feet eventually opening into a short channel flowing into Crowell Pond. The tide gauge was installed for preliminary remediation studies.

In 1999, Yarmouth officials requested assistance from the Army Corp of Engineers to review this site for potential remediation. To date preliminary studies have been undertaken, which suggest that two 5 by10-foot culverts would restore natural tidal flow between Crowell Pond and the Bass River/Nantucket Sound. However, low-lying development in the upstream affected area now makes total flow restoration impossible. Further studies are needed and will be conducted over the next several years to develop a restoration plan that will improve the rate and quantity of flushing while eliminating the flood hazard to low-lying, developed properties.

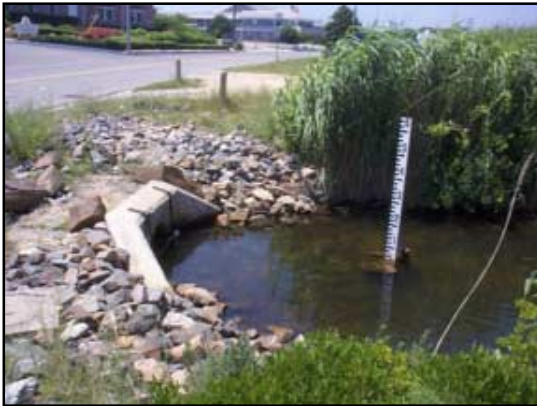
View of the upstream 33-inch opening, with head and wing walls, near Crowell Pond.
