Cape Cod Atlas of
**Tidally Restricted
Salt Marshes**

Cape Cod, Massachusetts

Conducted & Prepared by
Cape Cod Commission
for the
Massachusetts
Wetlands Restoration Program

December, 2001

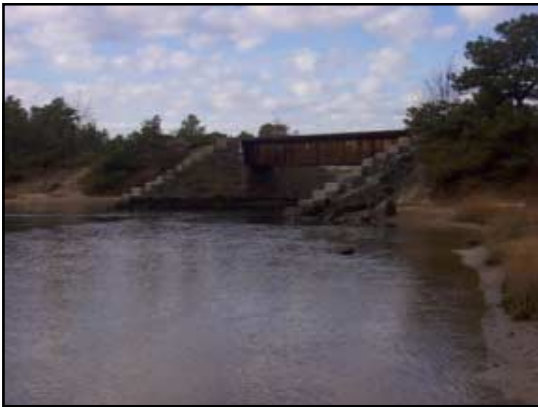
The now unused railroad bed is seen restricting the Bass River, only allowing water to flow through a 63-foot opening.

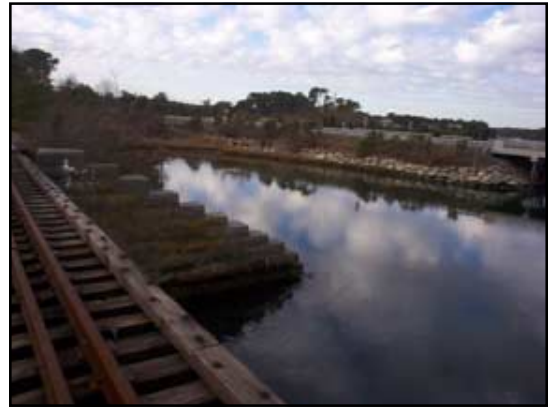
Water pools between the railroad bed and Route 6 causing bank and riverbed scour.
